The Corporation of the Town of Milton

Report No: DS-015-26

Subject: Recommendation Report _Relocation of Socrates Center house at 94 Peru Road

HERITAGE CONSERVATION PLAN

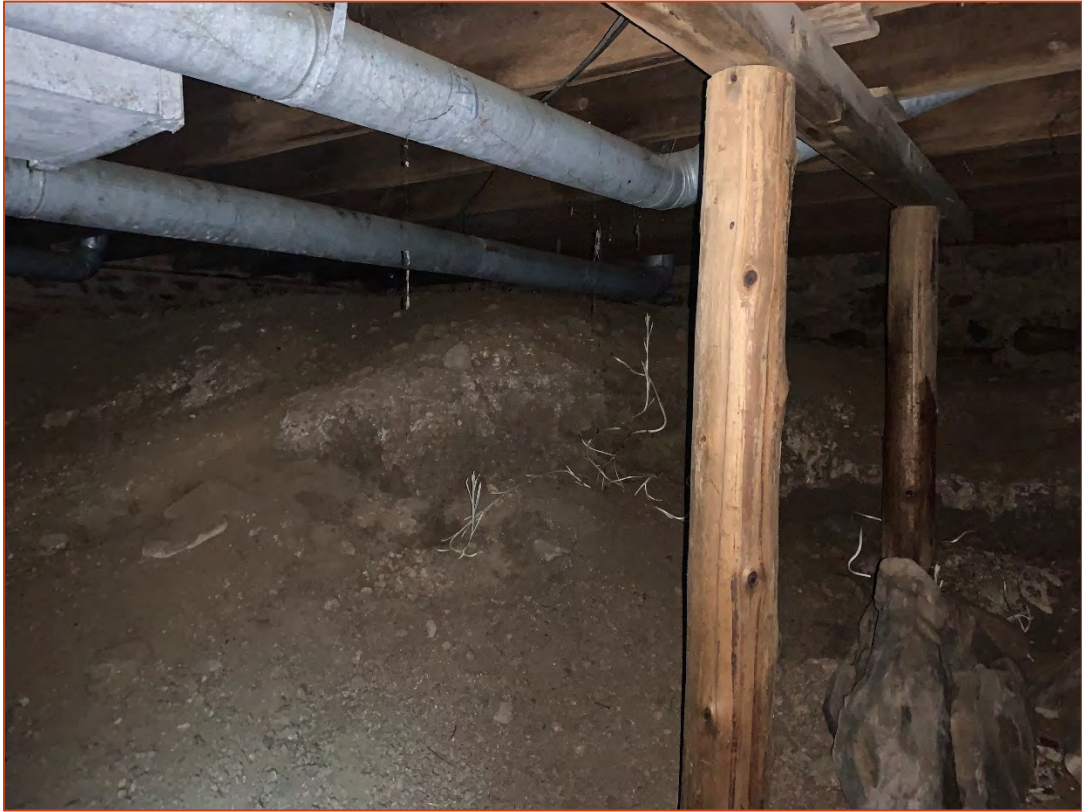
The basement is accessed from the kitchen and is one large room with access to the crawlspace on the northeast wall under the front part of the house (Figure 15 and Figure 16). The coursed rubble foundation walls are exposed. Milled beams support the house.

Figure 15: View of the crawlspace (Tacoma, 2020)

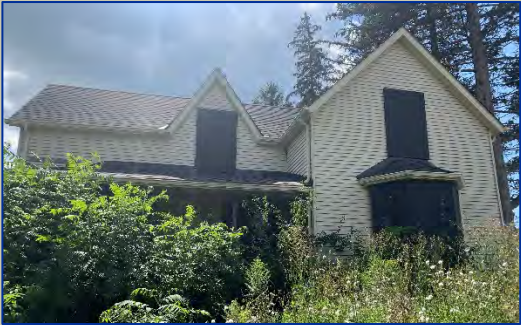
Attribute	Description	Photograph	Rating
<p>Location of house close to the village of Peru</p>	<p>The Property is in its original position relative to the village of Peru. The house is linked to the growth and development of the village of Peru and industrial development within the Peru and Milton Heights area.</p>	<p>N/A</p>	<p>Good</p>
<p>The original “L” shaped form, rooflines, and massing of the one and a half storey house exterior (With the exception of the rear single garage)</p>	<p>The “L” shape became popular in the mid to late nineteenth century. The plan is often representative of vernacular mid-Victorian domestic architecture.</p> <p>The general shape and form of the structure is intact.</p>

<p>Good</p>

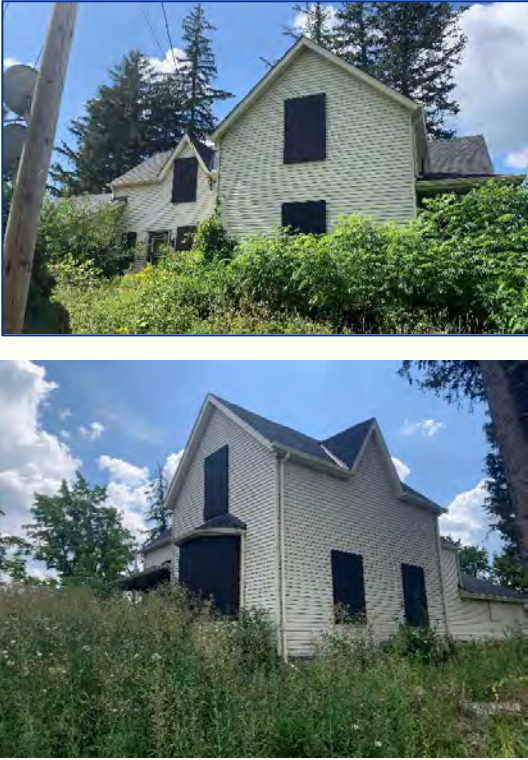
Attribute	Description	Photograph	Rating
<p>Size and location of the window and door openings</p>	<p>The size and location of the windows and door openings are generally intact.</p> <p>As a result of the interventions for the roof replacement, it was possible to confirm the existence of an arched gable window on the north elevation. This window appears to have been sealed as a result of interior alterations to the front rooms on the second floor.</p>

<p>Good</p>

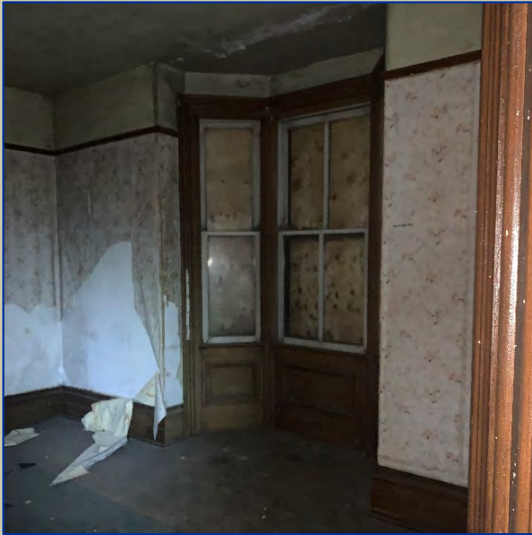
<p>North elevation bay window</p>

Attribute	Description	Photograph	Rating
<p>Ground floor bay window and second floor arched gable windows</p>	<p>Windows are generally intact but require some restoration work.</p>

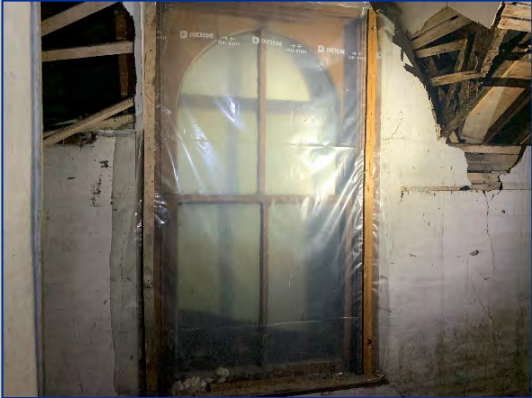
<p>Arched gable windows</p>	<p>Fair</p>

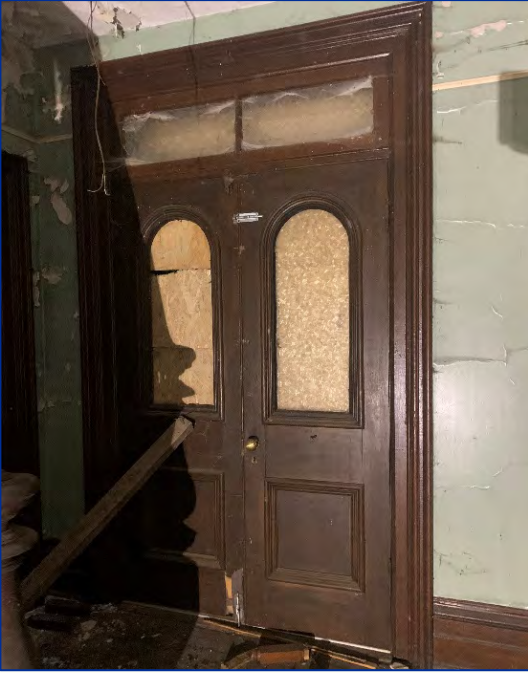
Attribute	Description	Photograph	Rating
<p>Double front entrance doors with transom window above</p>	<p>Double front entrance is generally intact but will require some repair and restoration.</p>

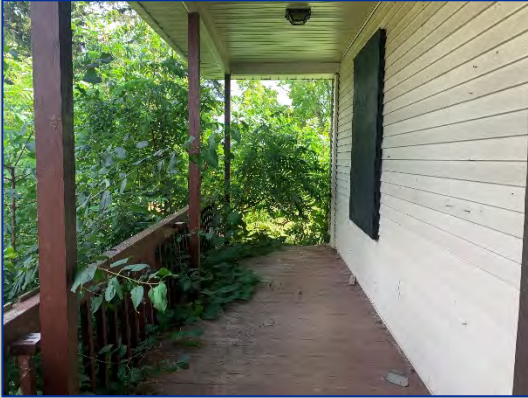
<p>Fair</p>
<p>The location of the front entrance porch</p>	<p>The location and scale of the front entrance porch appears is intact; however, the porch deck, foundations, railings and posts (which appear to be 20th century replacements) require extensive intervention.</p>

<p>Fair</p>

- Document the construction and details of the front porch and label its parts. Determine which parts can be used to rebuild the porch following relocation and which need replacement. If necessary, prepare plans for replication of damaged historic decorative elements.

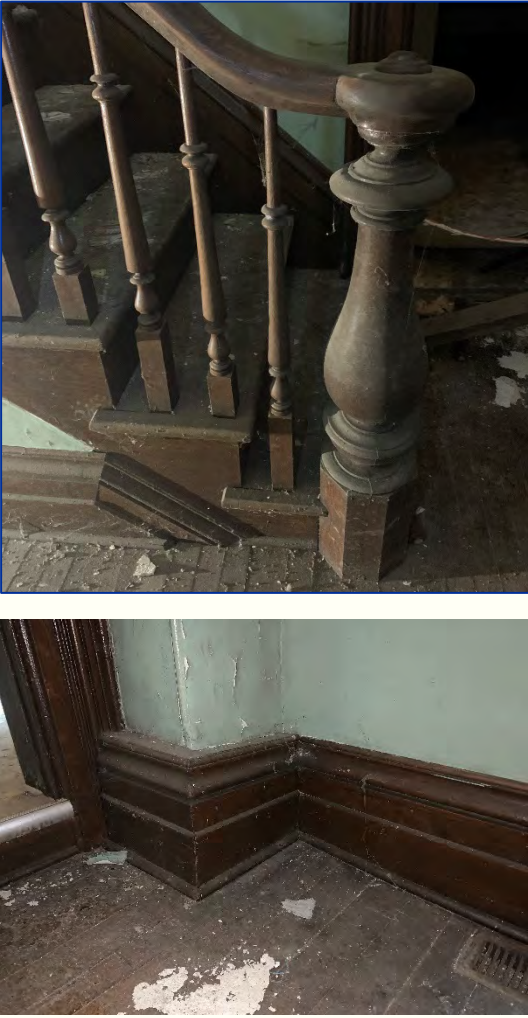
Attribute	Description	Photograph	Rating
<p>Millwork on ground floor (two front rooms, entrance hall, and main staircase)</p>	<p>In general, the millwork on the ground floor (in the front entrance hall and two front rooms) is in generally fair conditions. Some elements are in good to excellent condition and will only require surficial intervention, while other components may require more invasive intervention/repair or partial replacement.</p>

<p>The top photograph shows a close-up of a wooden staircase balustrade with a curved handrail and decorative balusters. The wood appears aged and slightly worn. The bottom photograph shows a corner of a room with dark wood baseboards. The floor is made of dark wood and shows significant damage, including a large area of missing material and peeling paint on the wall above the baseboard.</p>	<p>Fair</p>

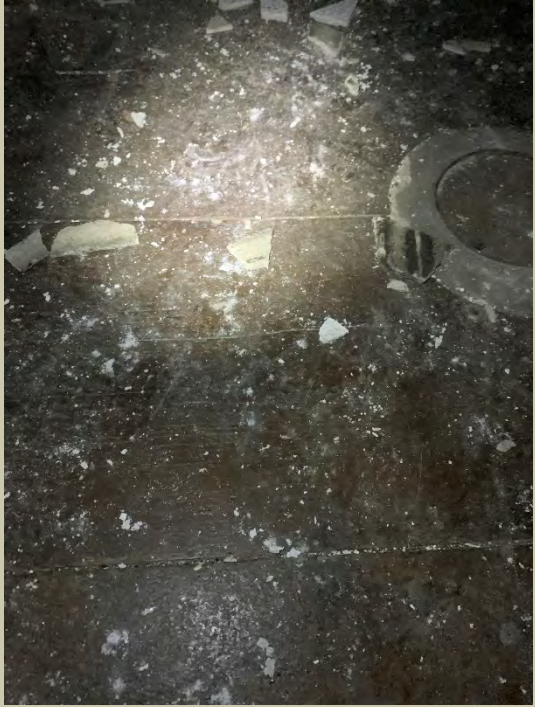
Attribute	Description	Photograph	Rating
<p>Wide floorboards in second floor front two rooms and hallway</p>	<p>The wide second floor floorboards in the front rooms and hallway appear to generally be in fair condition. However, repairs and, likely partial replacement of some boards, appears to be required.</p>

<p>Fair</p>
