The Corporation of the Town of Milton

Report No: DS-029-21

Subject: Heritage Easement Agreement for the property at 7419 Tremaine Road - Alex Hogg Stone House

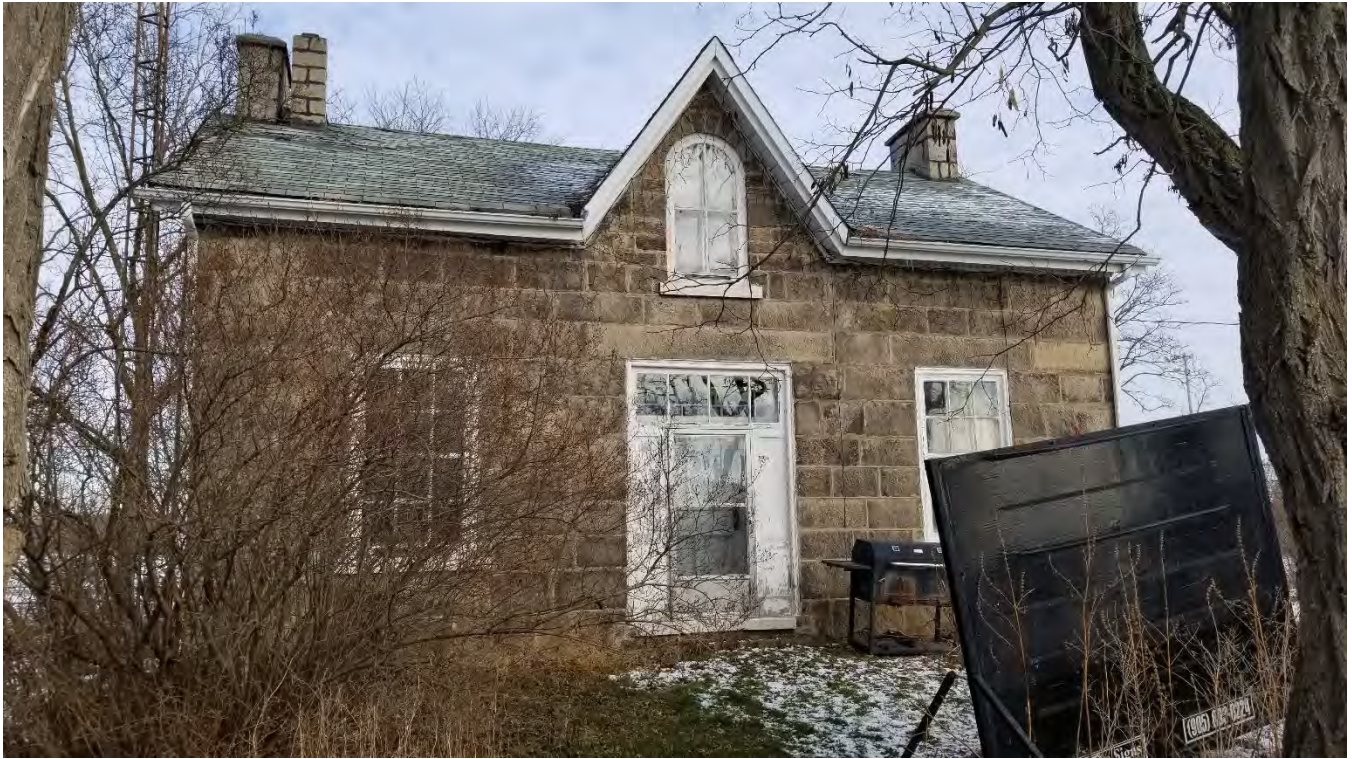
Figure 11: South façade

The main block of 7419 Tremaine Road is a single-detached, one-and-a-half storey structure with a rectangular long façade which measures 10.4 m by 7.1 m (Figure 11 to Figure 14). It has a full basement and stands on a coursed rubble fieldstone foundation (Figure 15). It is clad in cut stone in even courses and double stuck mortar joint, with a stone thickness of approximately 23.5 cm. The medium gable roof has a centre gable on the south façade with moulded fascia (Figure 16). There are three single chimneys; two stone, and one concrete block, located at the offset left and right.

The six-over-six windows have a wood lug sill and stone lintel with bush hammered edges (Figure 17). The centre gable on the south façade has a four-pane semi-circular window and there are small basement windows. Windows on the second storey, although also six-over-six, are smaller in scale than the first storey and also have a stone lintel with bush hammered edges. The one leaf, four panel main entrance on the south façade has a four pane transom and sidelights which have been boarded up and again has stone lintels with bush hammered edges (Figure 18). It has a glazed storm door and there are no stairs leading up to it.

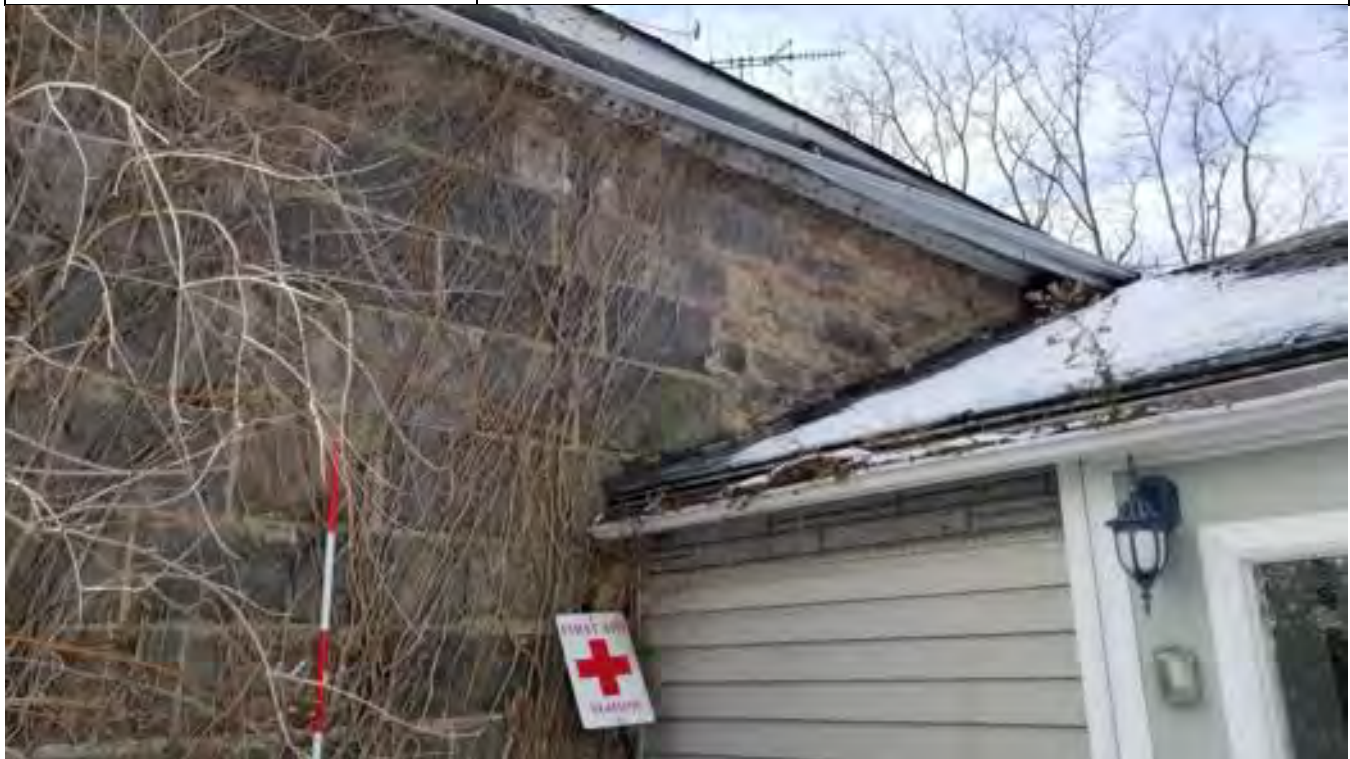
Figure 57: Evidence of cracking on the north facade wall of the Main Block

Element	Observed Conditions
General structure	<ul style="list-style-type: none"> ■ Overall the main block of the house is in good condition ■ The extension is in fair condition
Roof	<ul style="list-style-type: none"> ■ The main block roof appears to be in good condition with some areas requiring repair near the chimney ■ The extension roof is in fair condition
Rainwater disposal	<ul style="list-style-type: none"> ■ The metal gutters and downspouts are in good condition
Walls, foundations & chimneys, exterior features	<ul style="list-style-type: none"> ■ Walls and foundations appear to be in overall good condition ■ North façade of the main block shows evidence of damage (Figure 57) ■ The chimneys are in good condition
Windows & doors	<ul style="list-style-type: none"> ■ Windows and doors appear to be in good condition, although some wood lug sills may require replacement
Internal roof structure/ceilings	<ul style="list-style-type: none"> ■ Pieces of the ceiling in the mudroom require replacement and are exposing lath ■ A large portion of the kitchen ceiling has collapsed (Figure 58)

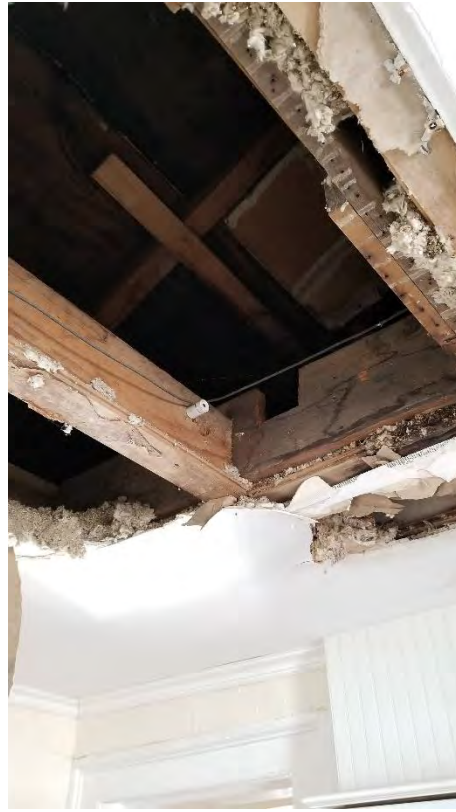
Figure 58: A portion of the collapsed ceiling in the extension kitchen

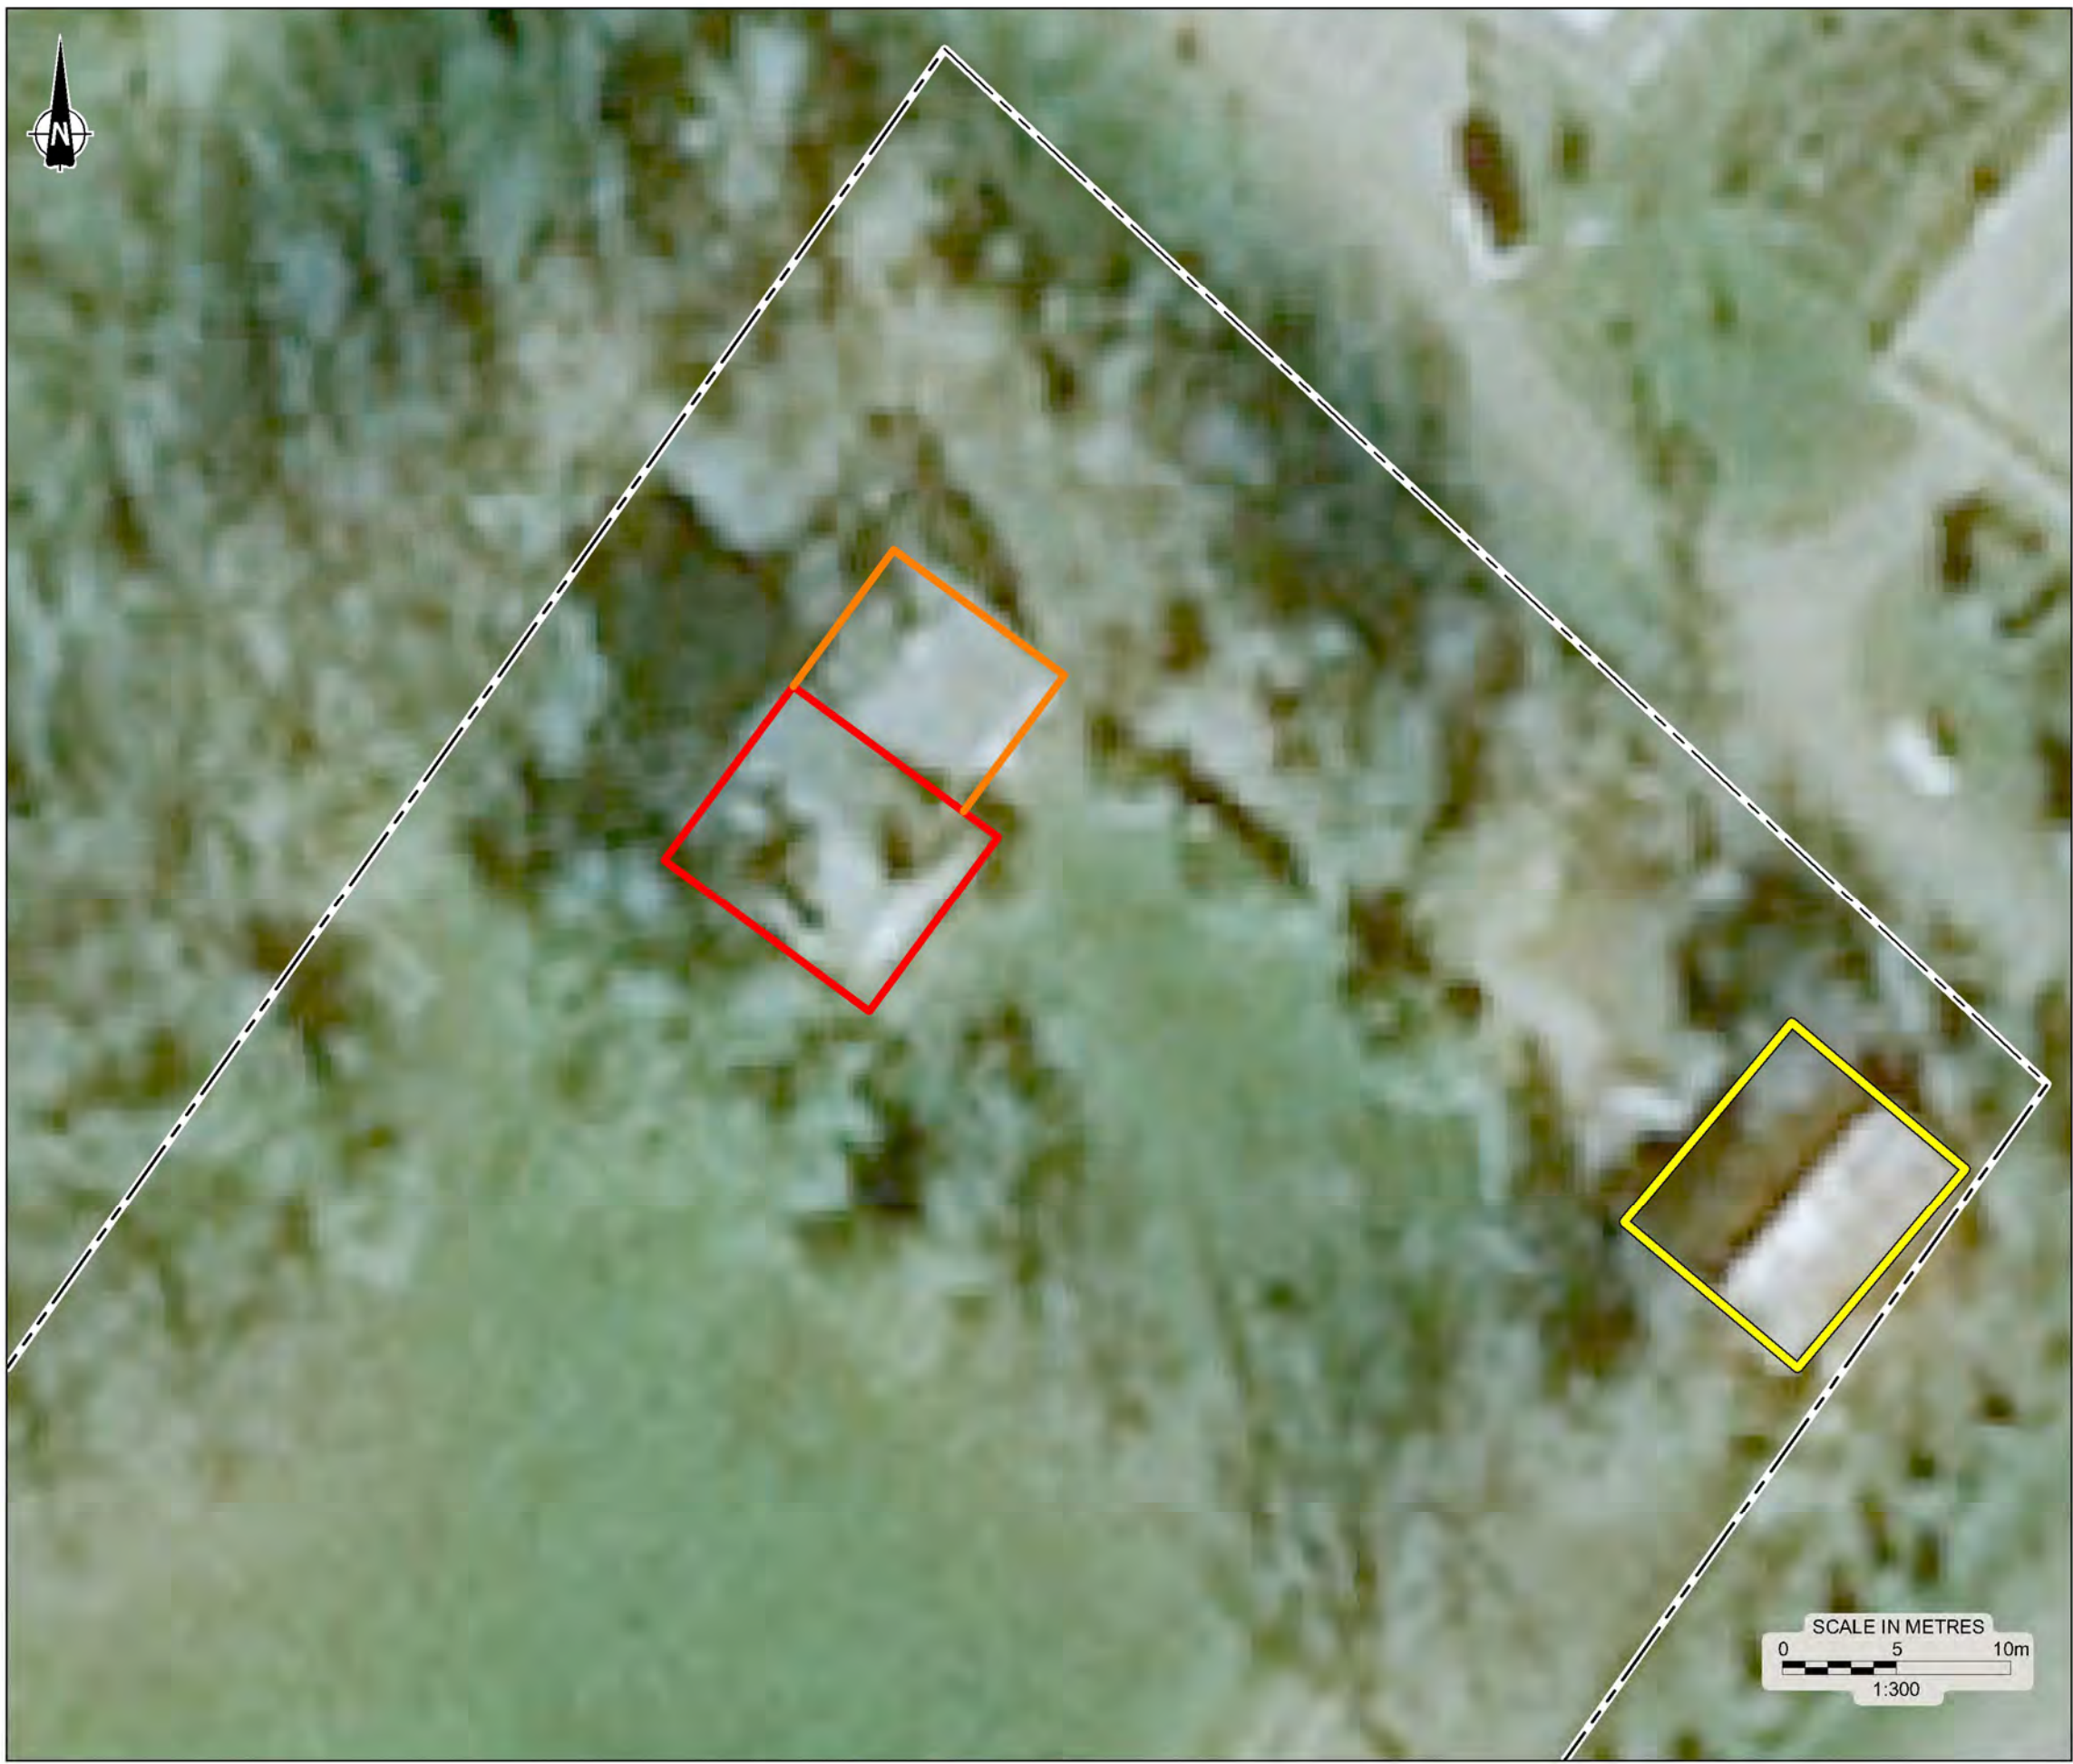
- APPROXIMATE LOCATION OF SUBJECT PROPERTY
- PHASE 1 - CIRCA 1830s TO 1940s (Construction)
- PHASE 2 - CIRCA 1940s TO 2018 (Construction)
- PHASE 3 - 2018 TO PRESENT (Demolition)

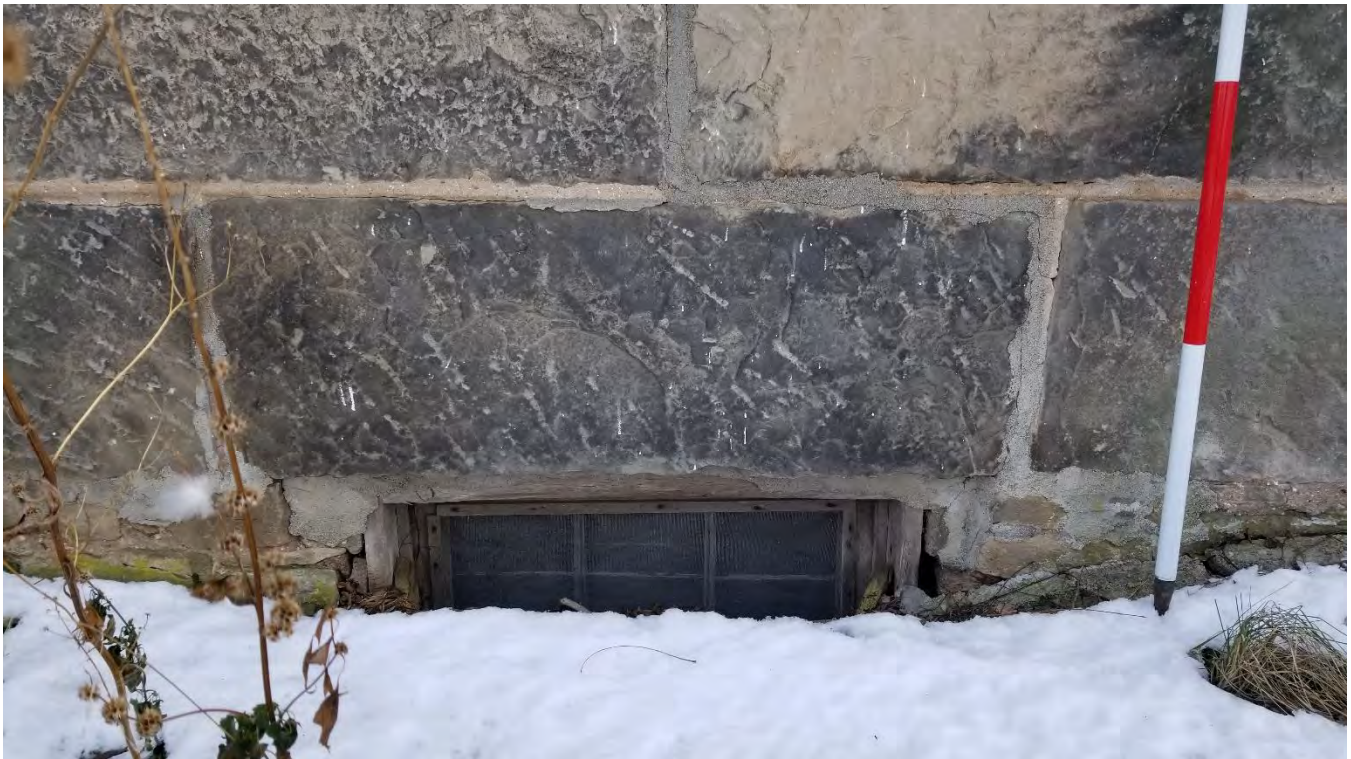
Figure 14: Ashlar masonry above the coursed rubble foundation

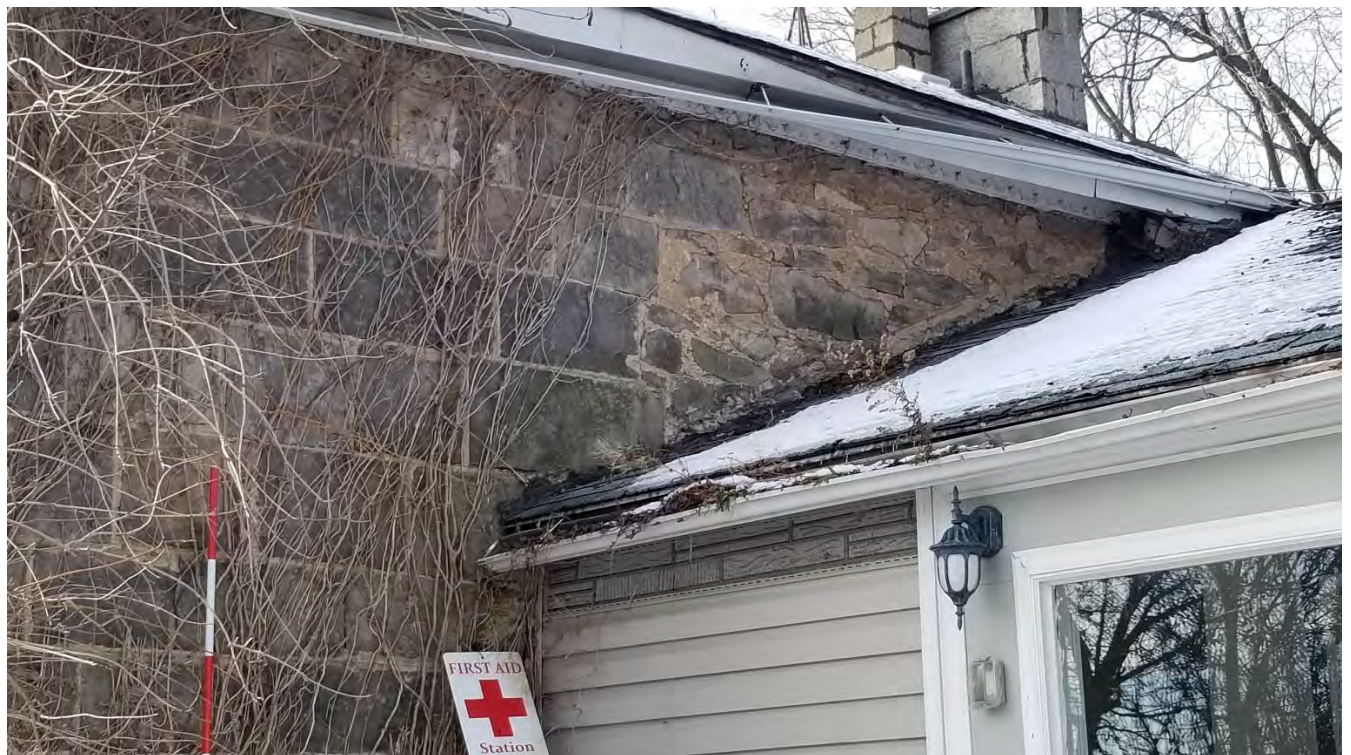
Figure 15: Section of rubble masonry on the north wall

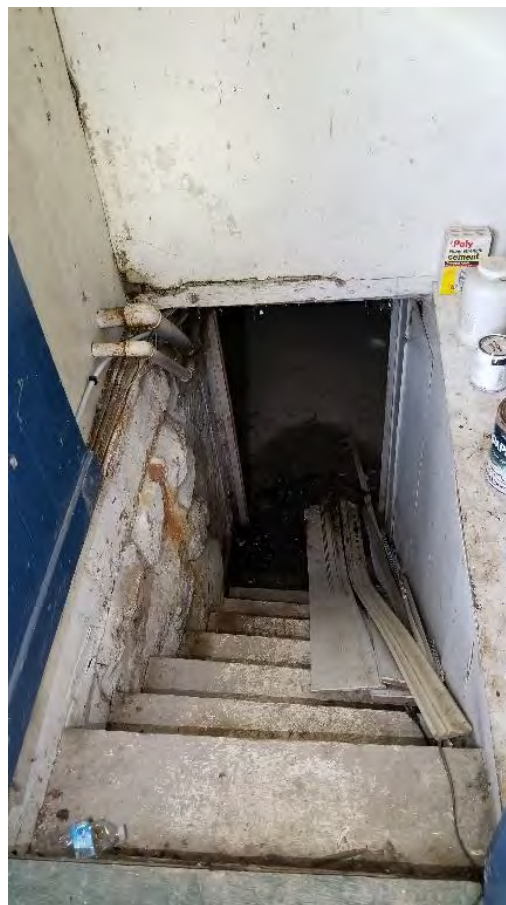
Figure 38: Stairs leading to the basement

The full height basement is accessed through straight stairs in west room of the rear wing (Figure 38). The floor of the basement is either unfinished or concrete slab and the foundation walls are exposed. A thick stone partition wall divides the north and south portions of the space with wood panelling was used to create other partitions (Figure 39 and Figure 40). At the southwest corner is a utility room with an oil tank and window on the south wall while to the north is a larger room with two windows on the north wall (Figure 41 and Figure 42). The first level framing is visible in the basement ceiling and includes a large hand-hewn beam that run the east-west length of the house and supported by hand-hewn posts. Running north-south are the joists, which are whitewashed and planed, leaving no visible saw marks, and above these is the wide planking of the first level floor (Figure 43).

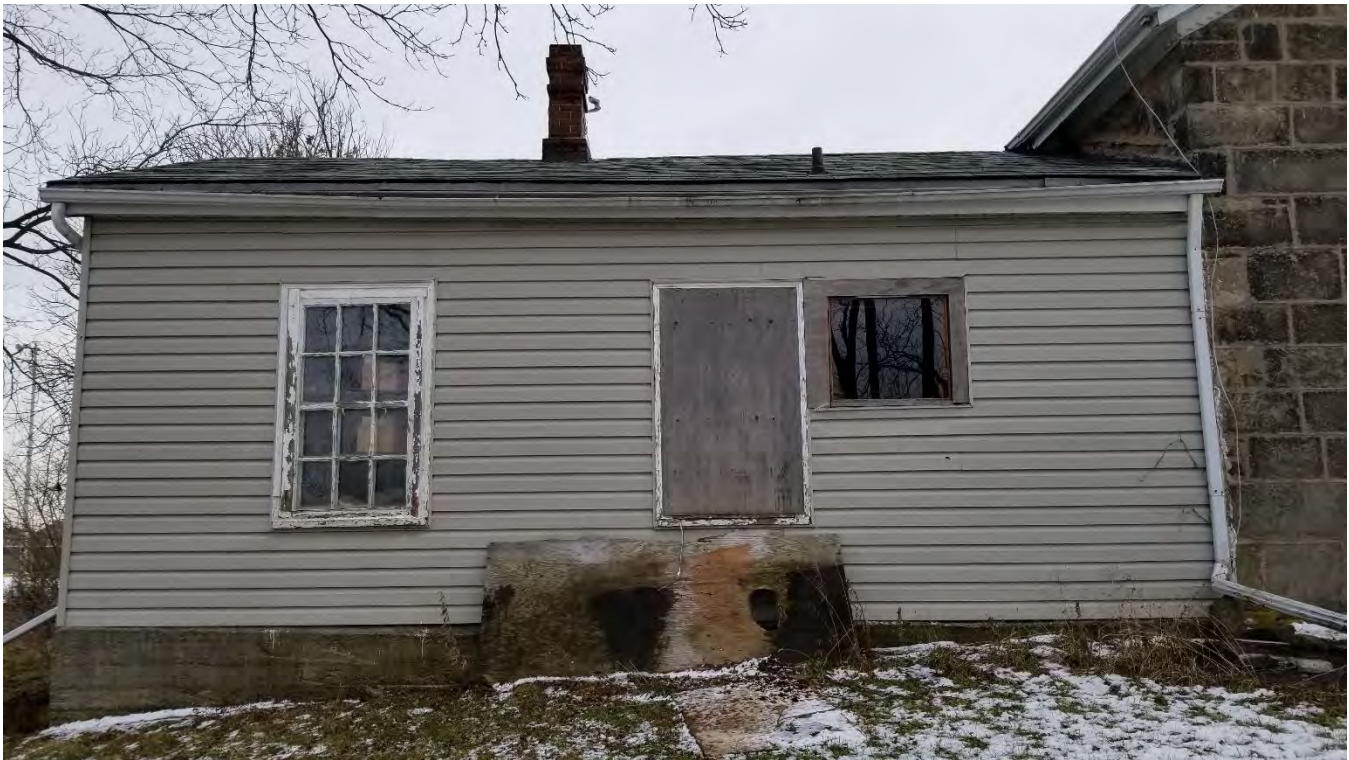
Figure 44: West façades

Fenestration is asymmetrical with two tall windows—one six-over-six double hung and the other blind— as well as a directly adjacent single fixed sash window on the west façade. On the north end wall is a square six-over-three window and a blind entrance with small hood, while on the east façade is a glazed central entrance with adjacent large “picture” fixed sash.

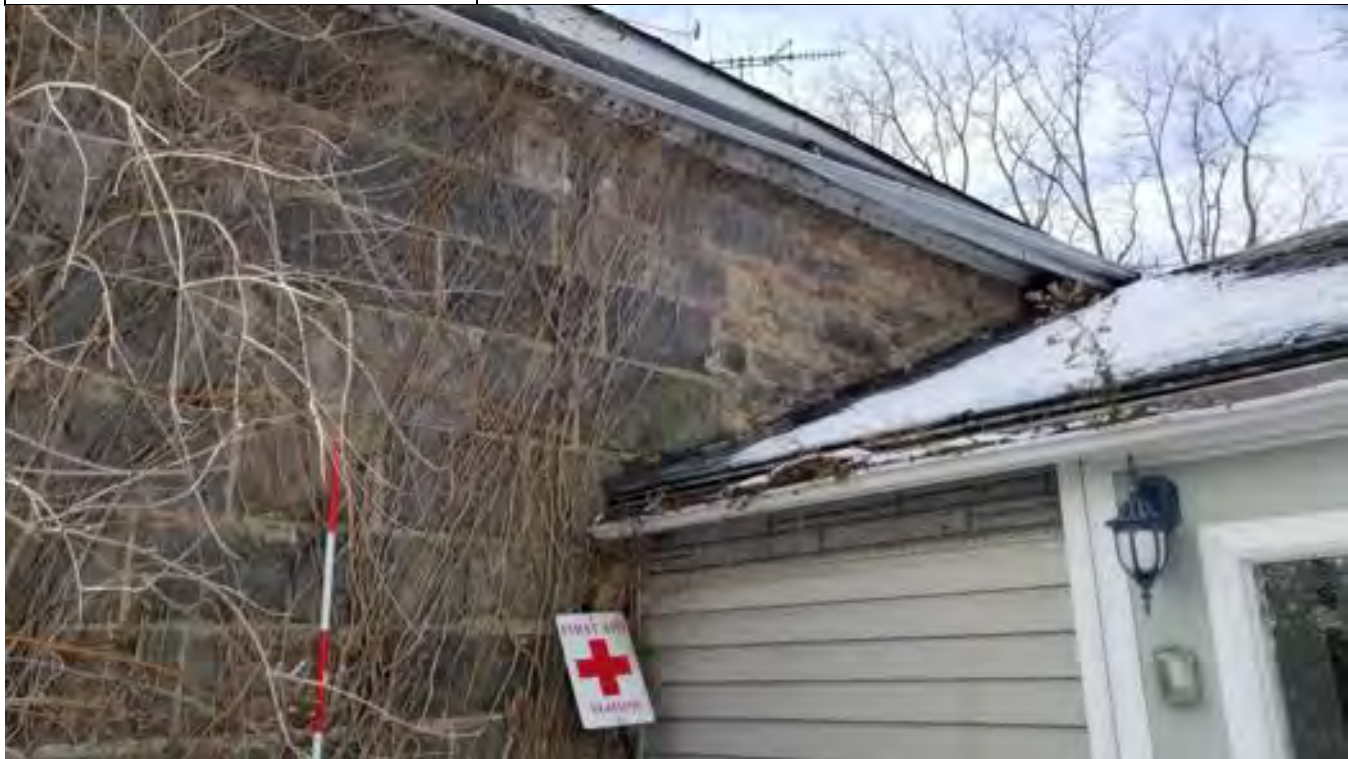
Figure 57: Evidence of cracking on the north facade wall of the Main Block

Element	Observed Conditions
	<ul style="list-style-type: none"> ■ Wood trim (baseboards and crown moulding) are in good condition
Fixtures & fittings	<ul style="list-style-type: none"> ■ Built-in cabinetry in the bathroom is in poor condition ■ Lighting appears to be operable and in good condition
Building services	<ul style="list-style-type: none"> ■ The collapsed portion of the kitchen ceiling has exposed knob and tube wiring (although it may not still be connected) ■ Knob and tube wiring is also visible in the basement
Site & environment	<ul style="list-style-type: none"> ■ Some vegetation close to the foundations may be physically impacting the structure ■ There are no visible areas of standing water
General environment	<ul style="list-style-type: none"> ■ The main block is in overall stable condition ■ The extension is in fair condition

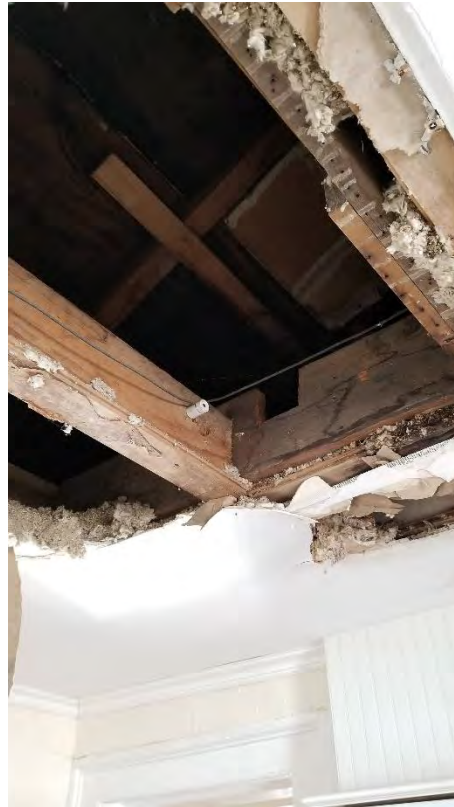
Figure 58: A portion of the collapsed ceiling in the extension kitchen

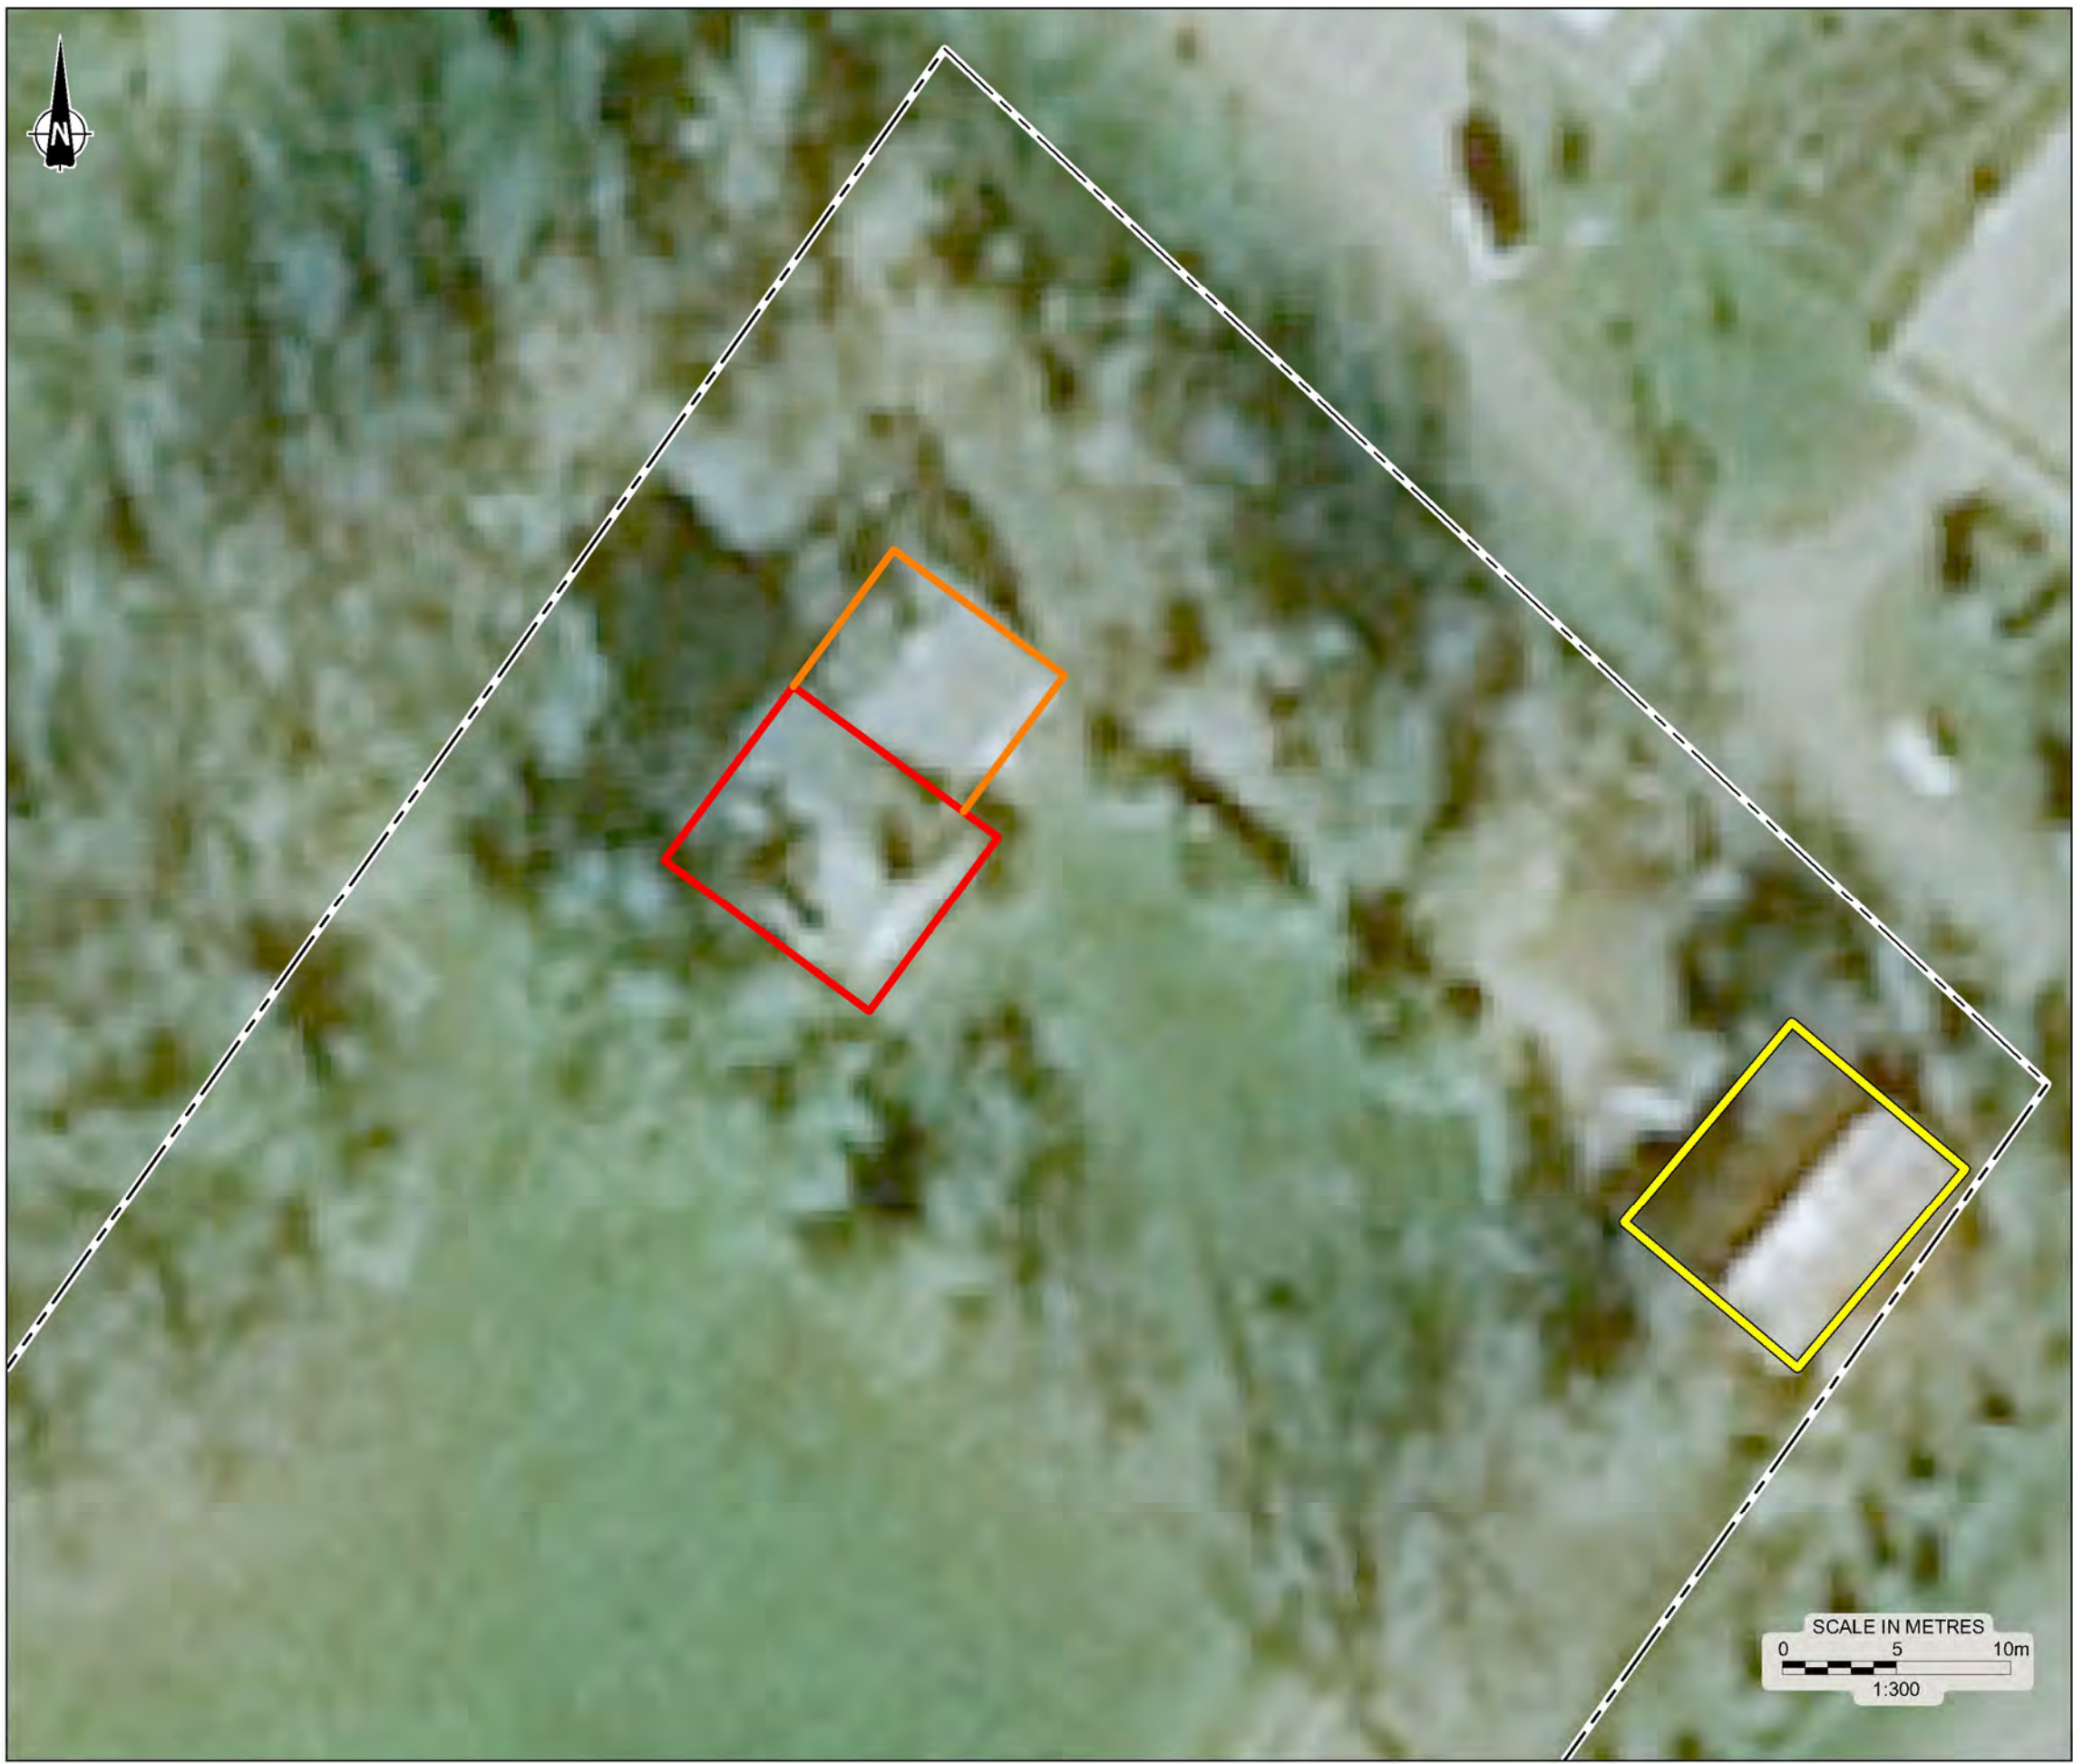
- APPROXIMATE LOCATION OF SUBJECT PROPERTY
- PHASE 1 - CIRCA 1830s TO 1940s (Construction)
- PHASE 2 - CIRCA 1940s TO 2018 (Construction)
- PHASE 3 - 2018 TO PRESENT (Demolition)

- demolition of the barn to the east of the house

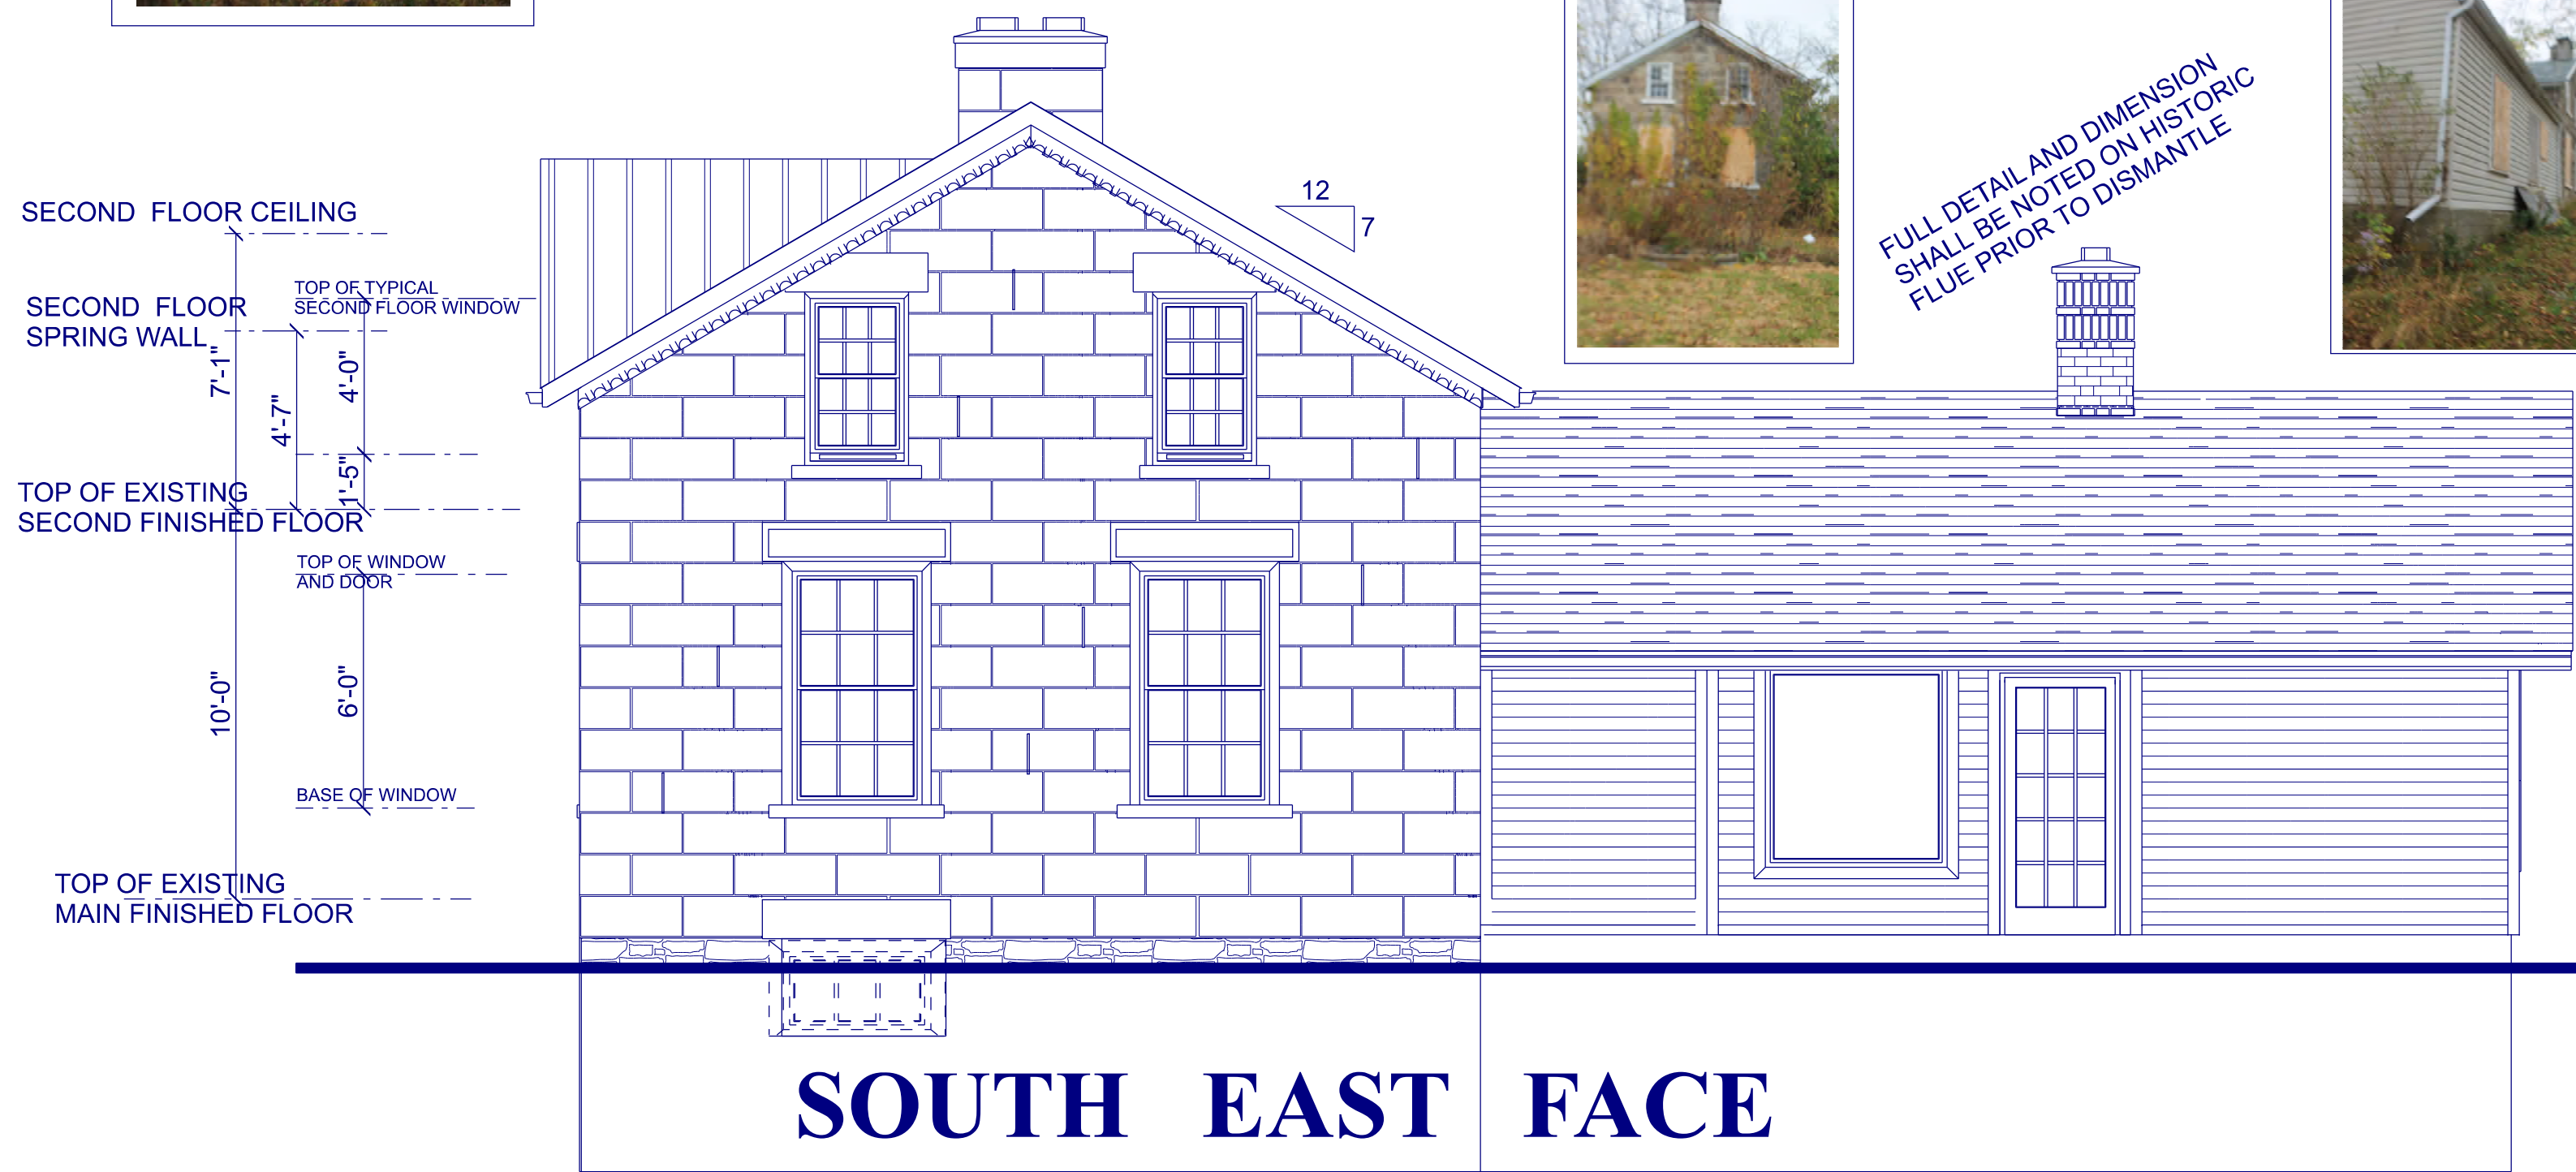
SOUTH EAST FACE

MODERN HORIZONTAL VINYL SIDING

REGULAR COARSED ASHLER CONSISTENT HEIGHT VARYING WIDTHS BEADED MORTAR JOINTS SOME VARIATION SOME LESS FORMALIZED STONE OVER BACK WING ROOF AND IN FRONT GABLE
