# The Corporation of the Town of Milton

Subject: Heritage Designation of the Thomas Bell Horse Barn at 10791 Fifth Line

# Heritage Impact Assessment

**The McLarty Residence,  
10791 Fifth Line,  
Milton (Nassagaweya), Ontario**

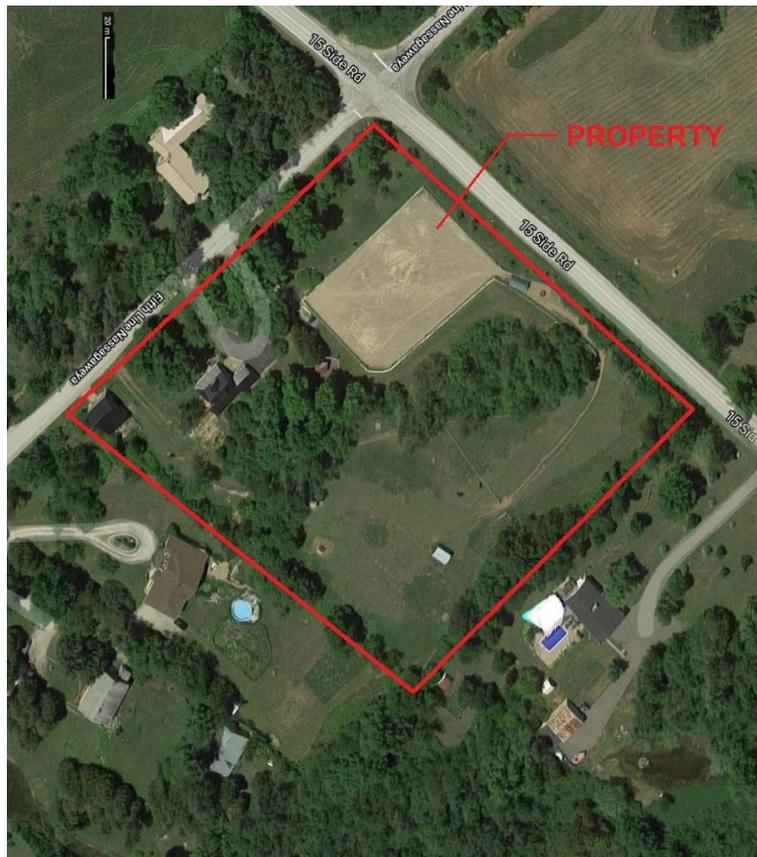
4.1.1.A - Aerial Photograph - Site

The buildings on the site consist of a one and a half storey residential home with a one storey addition, small horse barn and some small outbuildings/animal shelter structures. The property has been used as a hobby horse farm with a large sandy riding area/ring.

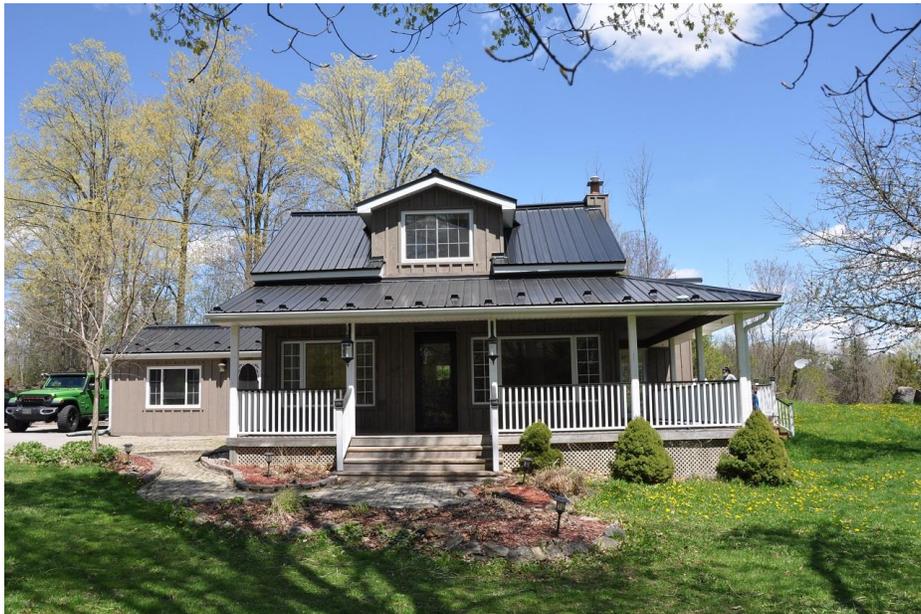
4.1.6.1.A - Existing West (Front) Elevation

The original home consists of a 1 1/2 storey building with a partial cellar built on a rubble foundation wall. It was built in the Architectural style of the traditional Georgian. A 1 storey addition with a crawl space built on a concrete block foundation wall runs across the rear of the home, which may have once been a summer kitchen, and now contains the kitchen. A one storey extension to the existing addition goes further north which served as a garage was built in the 1950's, but has since been converted to a bedroom with an ensuite. Another extension to the south, built in the 1980's, contains a breakfast area. A large porch built in the 1980's covers the West (Front) façade and wraps around along the South (Right) façade. Front and rear dormers were cut into the roof in the 1980's. A concrete block chimney was added when the heating system was changed to oil fired, forced air. The entire home is now clad in stained, vertical board and batten siding and with a standing seam metal roof.

The home is wood frame construction with a wood framed roof. A photo dated from the 1970's shows a stucco cladding at that time which now is vertical board and batten.

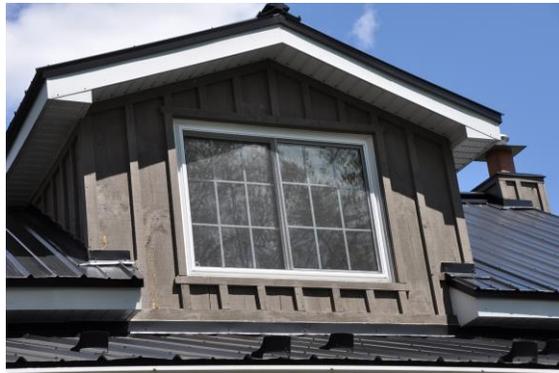
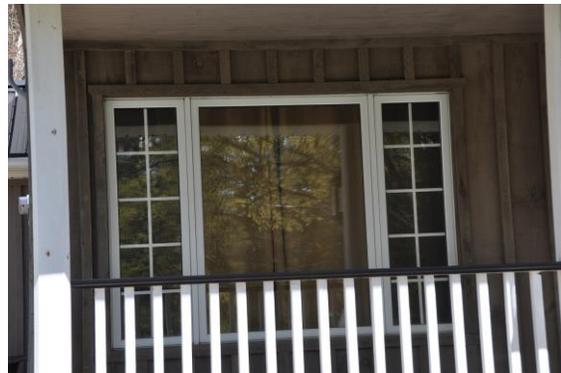
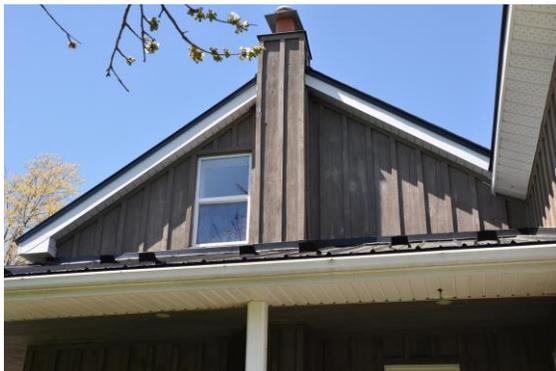
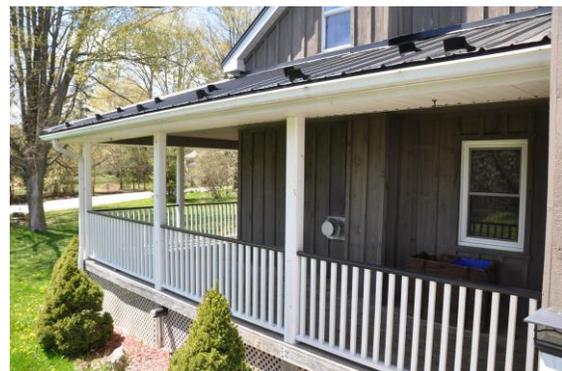
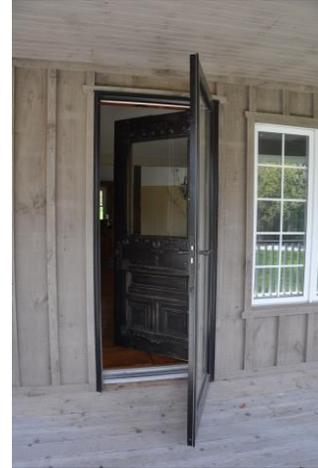
## 4.1.6.1.J – Exterior Details

- Vinyl vertical slider windows with plastic, snap-in grill, faux window mullions (non-original – mid-20<sup>th</sup> century),
- Pre-stained, vertical wood exterior siding, frieze boards and soffits (non-original – late-20th century)

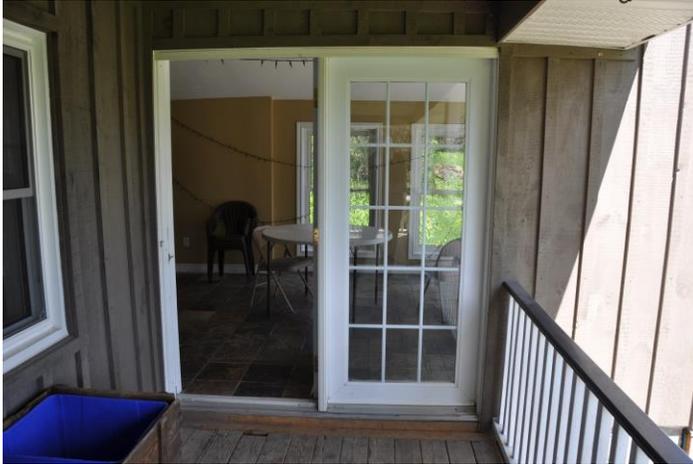
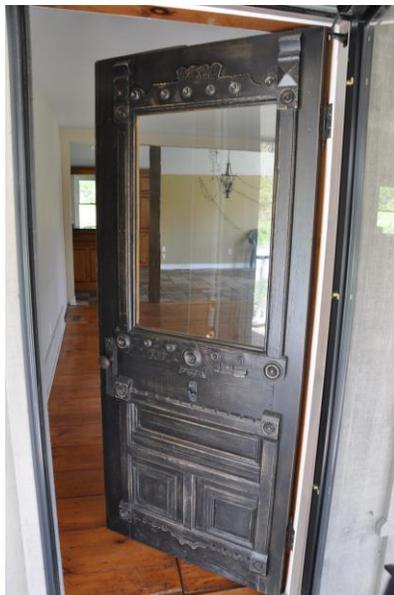
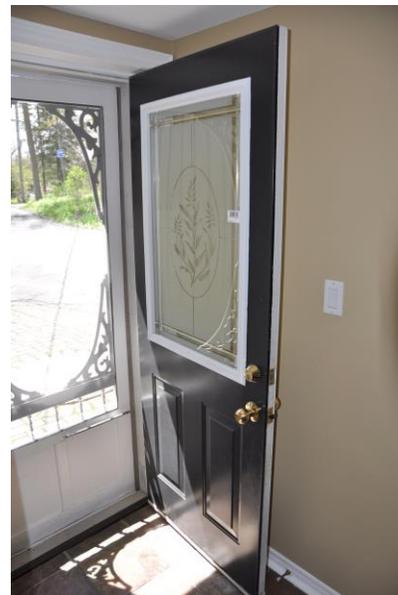
The floor plan is a 2-bay plan. Two principal rooms sit across the front of the home without a central hallway. A one storey addition run across the rear of the home extending beyond it to the north and south. Behind the easterly principal room, a bathroom has been installed. The rear addition houses the kitchen, a breakfast area and a bedroom suite.

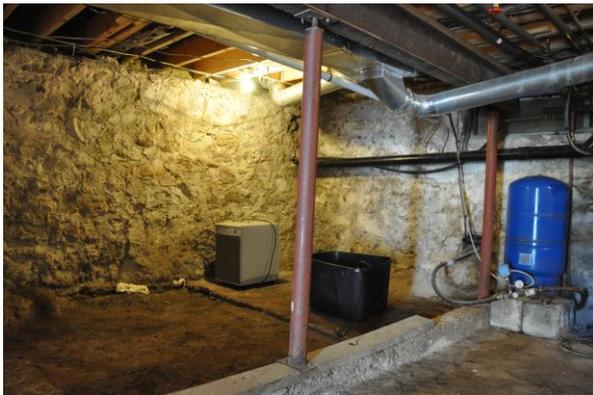
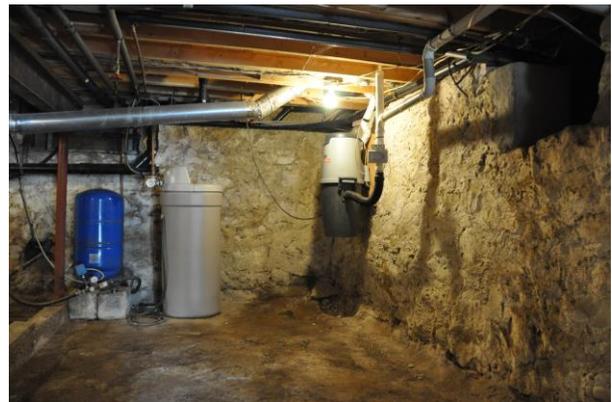
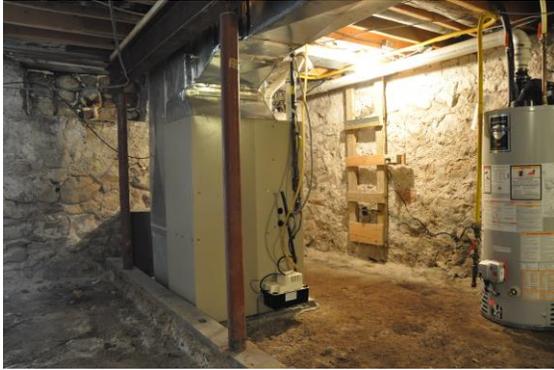
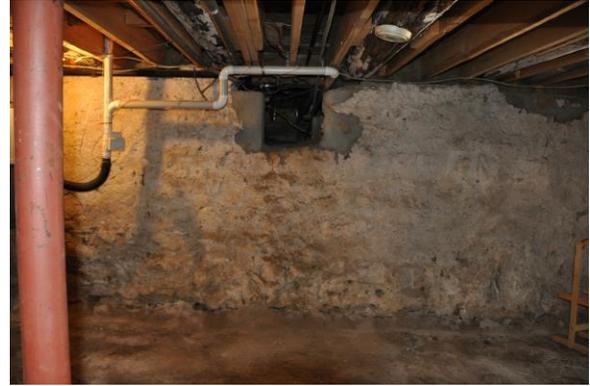
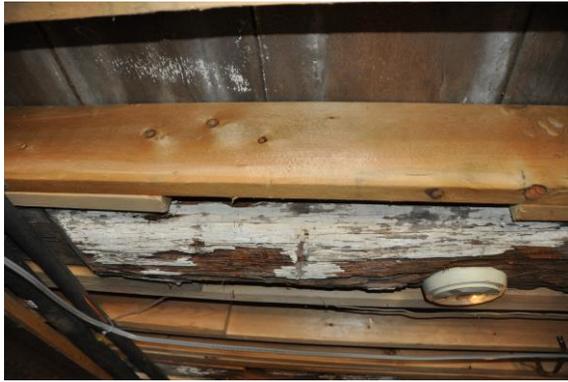
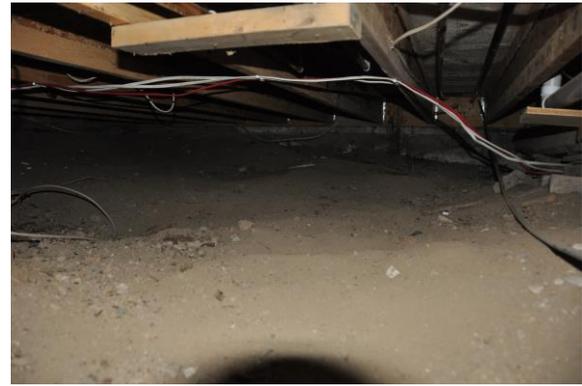
## 4.1.6.1.N – Cellar and Foundation Wall

The cellar would have been constructed for root storage. It has a new exterior stair access (1980's) leading to it from the south elevation and is of poured concrete construction. The foundation wall of the original home is painted, rubble fieldstone. The additions with crawl spaces are on concrete block foundations. The cellar houses electrical service, water softener and heating equipment. The ceiling height is approximately 1.95m (6' - 6") clear.

The structure of the home consists of:

- A rubble foundation wall – Original Home, (original, late-19<sup>th</sup> century)
- 190mm (8”) concrete block foundation wall – Additions (non-original, late 20<sup>th</sup> century)
- 38mm x 190mm @ 405mm o.c. (2” x 8” @ 16” o.c.) floor joists – Original Home (original, late 19<sup>th</sup> century) reinforced with 38mm x 190mm @ 405 o.c. (2” x 8” @ 16” o.c.) floor joists, 150 (6”) steel beam and 75mm (3 ½”) dia. Steel columns (non-original, late 20<sup>th</sup> century);

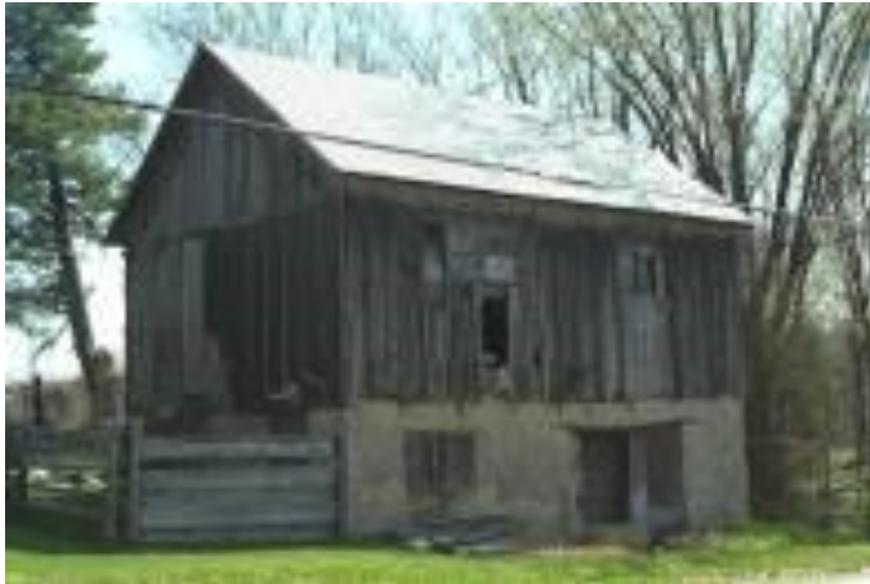
4.1.6.2.1.A – Horse Barn – ca. 1950

There are no horses or other livestock kept on the property at this time.

The physical condition of the Horse barn is good.

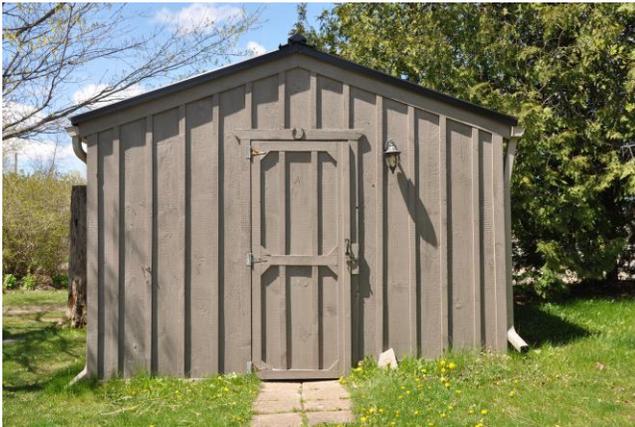
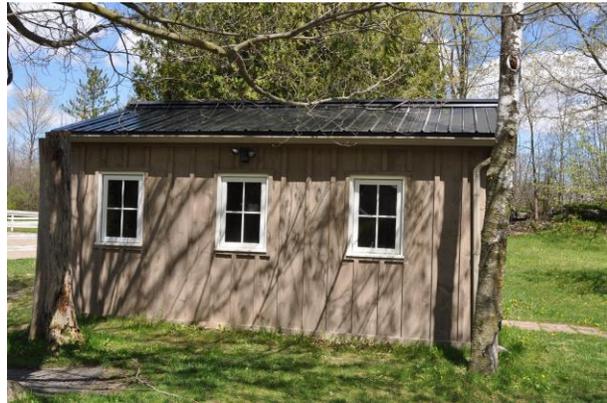
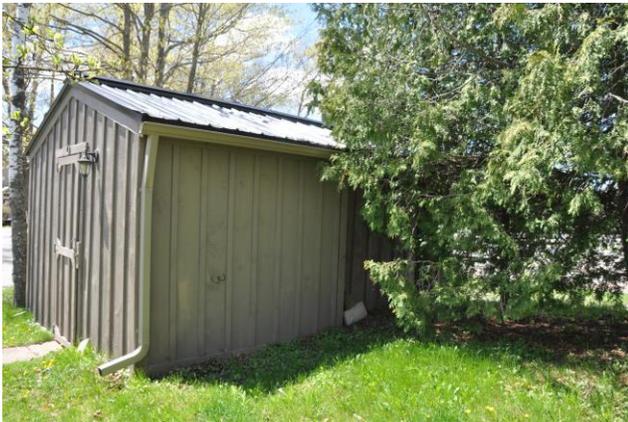
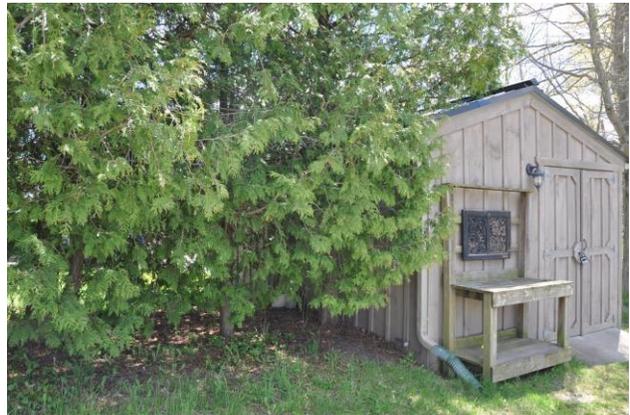
4.1.6.2.2.A – Shed No. 1 – Existing Exterior Elevations

It is used for garbage storage and recreational vehicle storage.

The Physical condition of the shed is good.

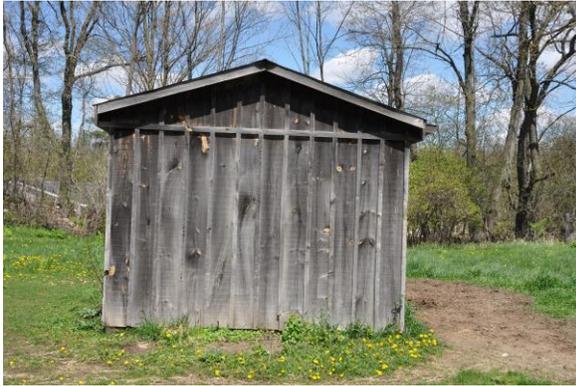
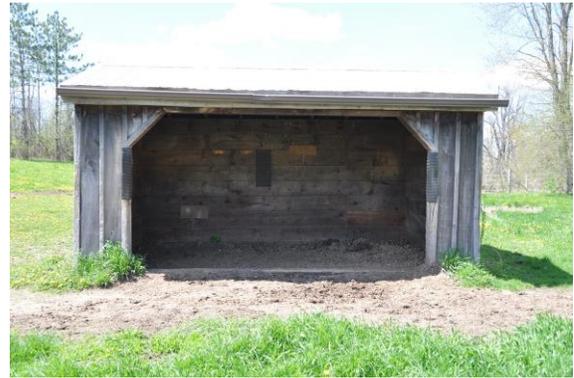
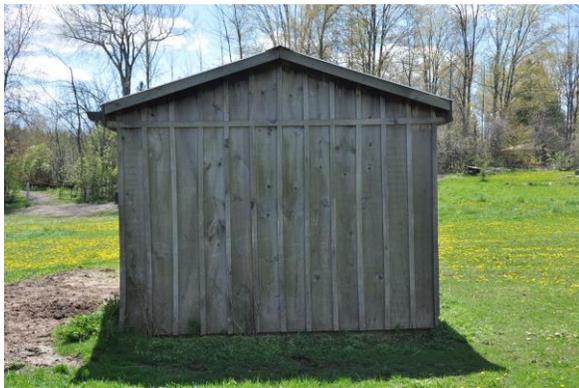
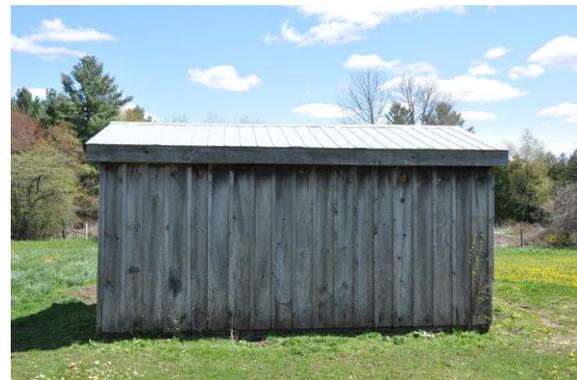
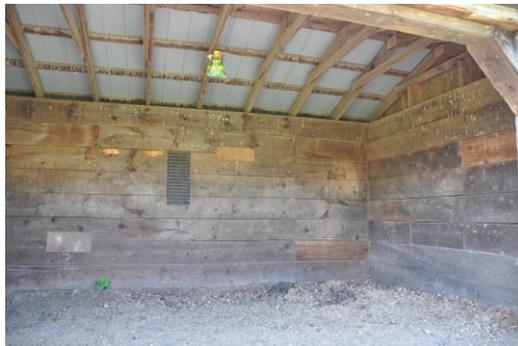
### 4.1.6.2.3.A – Horse Shelter – Existing Exterior Elevations and Interior

The Horse Shelter's dimensions are approximately 5.23m wide and 3.29m deep (17'-2" x 10'-10"). The structure is a wood frame with vertical stained board and batten wood siding and a standing seam metal roof. It was constructed in the 1980's, when the property became a fully equestrian use.

It was used as a shelter for horses at pasture.

The Physical condition of the horse shelter is fair.

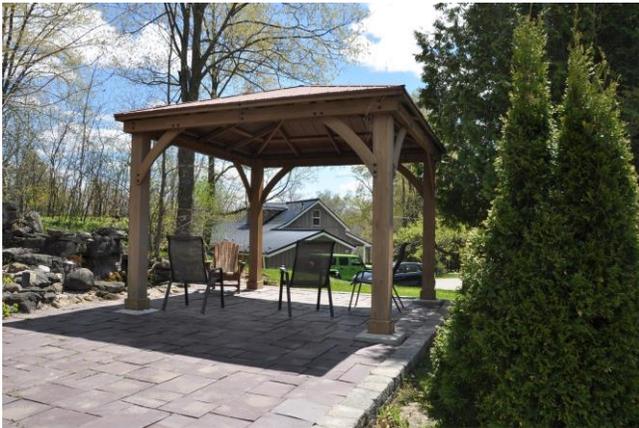
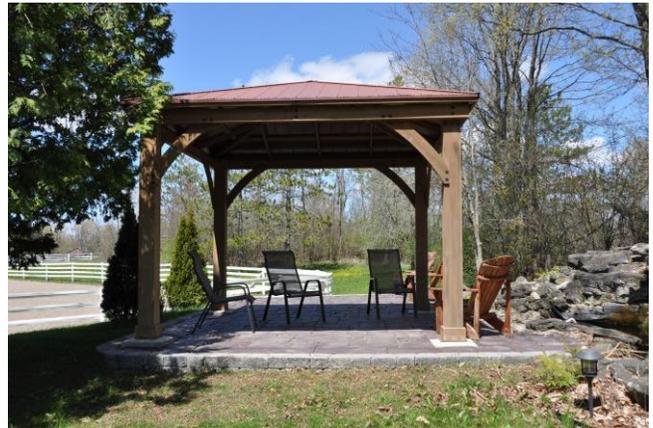
4.1.6.2.4.A – Gazebo – Existing Exterior

It was used as a viewing area for the riding ring.

The Physical condition of the gazebo is good.

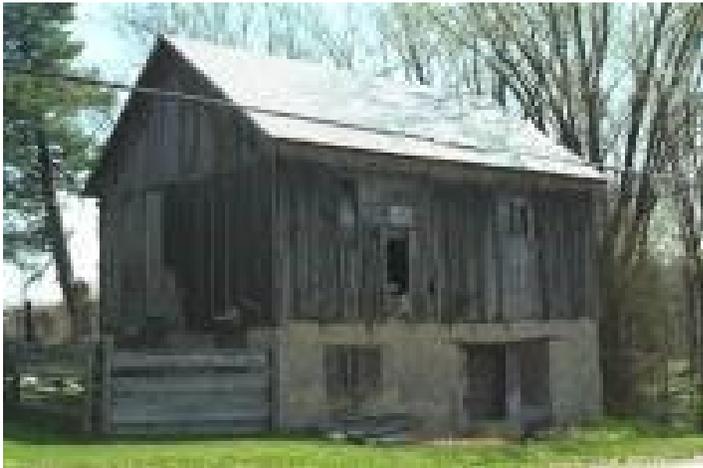
**Appendix 5: Horse Barn – ca. 1950**

The structure is a wood post and beam frame structure with vertical pre-finished wood siding and a standing seam metal roof. It has horse stalls on a lower level with a hayloft above it. A machinery storage area was added at the rear in the 1980's as part of the property's renovations. There are no horses or other livestock kept on the property at this time. The physical condition of the horse barn is good.

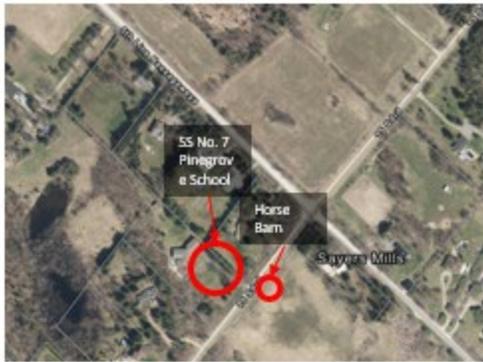
The location of the barn which forms part of the homestead setting and neighbourhood streetscape character of Fifth Line

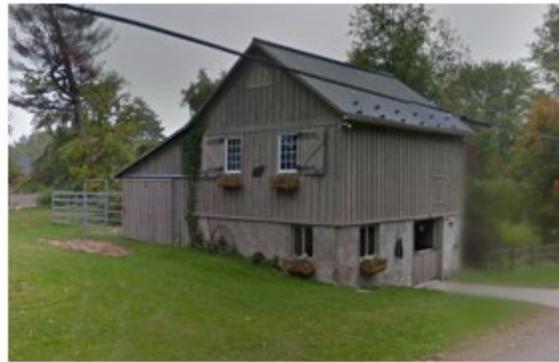
One- storey massing;

- One- storey massing;
- Low gable roof
- Rubble Wall foundation and vertical barn boards and batten siding.
- Square log timber framing, which is exposed to the interior;
- Asymmetrical fenestration with six-over-six and twelve-over-twelve light wood windows.

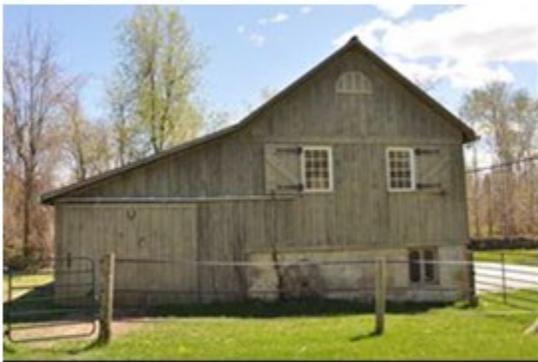
Rubble Wall foundation and vertical barn boards and batten siding

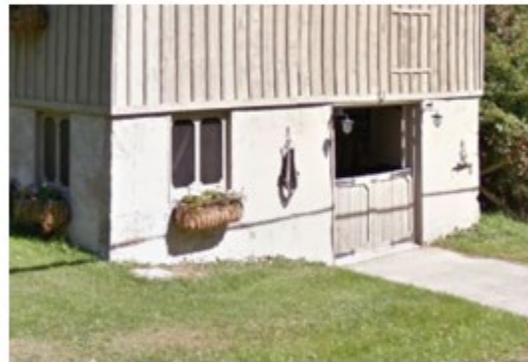
Low gable roof

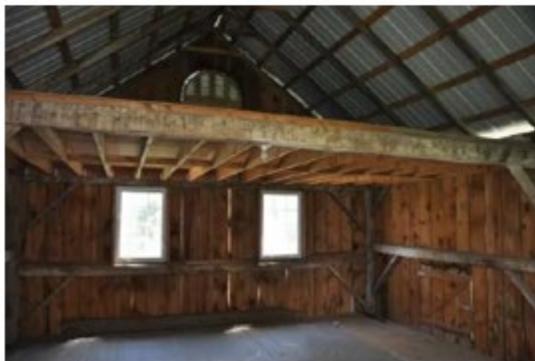
Square log timber framing, which is exposed to the interior

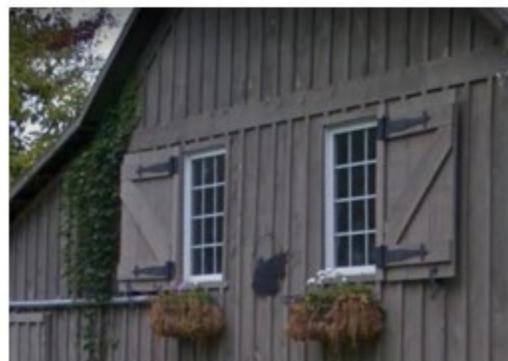
Asymmetrical fenestration with six-over-six and twelve-over-twelve light wood windows.
