# The Corporation of the Town of Milton

Report No: DS-034-22

Subject: 8350 Esquesing Line\_Outbuildings Demolition and Relocation of the Aitken Snow House Recommendation Report

8350 Esquesing Line, Milton, Ontario

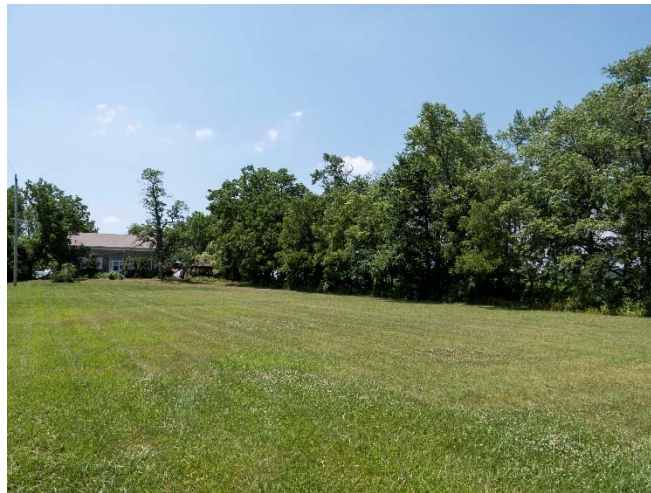
Figure 4: Looking northwest toward the farmhouse from Esquesing Line. The generous setback is apparent, with the line of trees right to the right outlining the driveway.

In the east of Lot 3, the farmhouse is set back roughly 80 meters from the historic concession road Esquesing Line (Figure 4). An unpaved, U-shaped driveway wraps around the house, the inner portion of which is grassed. Mature deciduous trees are found lining the western driveway, around the farmhouse, and continuing southeast from it. Behind the farmhouse are a collection of agricultural buildings and structures.

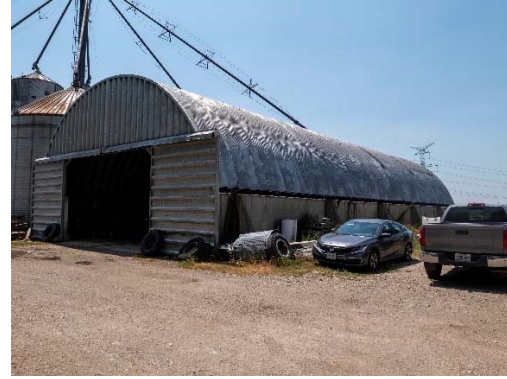
Figure 6: The quonset hut storage structure sits between the barn (to the right) and grain silo complex to the left.

Next to the barn is a one-storey quonset hut for storage, with galvanized top and sliding doors resting on concrete lower walls and foundation. Adjacent is a grain elevator and silo complex consisting of four metal silos with four metal hoppers connected via conveyors, and sheet metal-clad scale house.

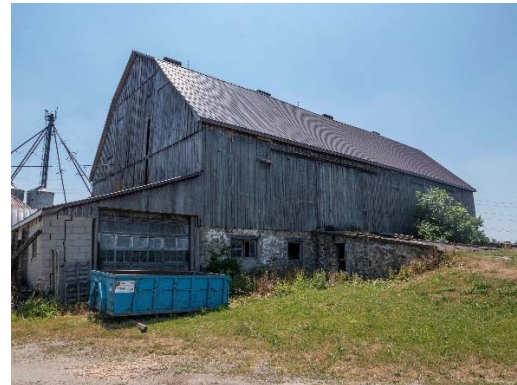
Figure 8: Looking southwest at the two-storey barn, showing raised embankment to the second storey entrance and shed roof addition at the left.

The two-storey barn sits on a rubble-stone foundation at grade, supporting the timber frame structure above (Figure 8) Access is from the side via raised earth embankment. It is clad with vertical boards (and occasional batten), with a sheet metal roof similar to that of the farmhouse. A concrete block addition was built on the east side with a shed roof and garage door. The barn's timber structure is composed of six bents (including end walls) of a three-bay design.

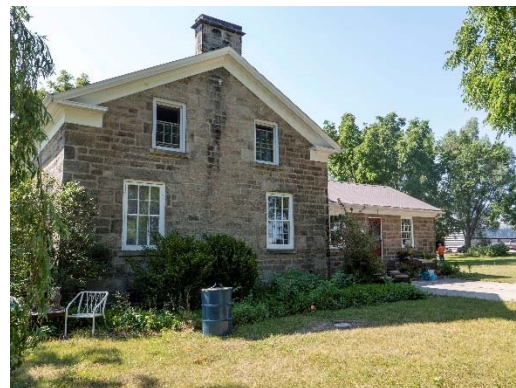
Figure 12: The north elevation is again defined by symmetry and proportion. The entrance off the rear wing is formal in design despite its secondary nature.

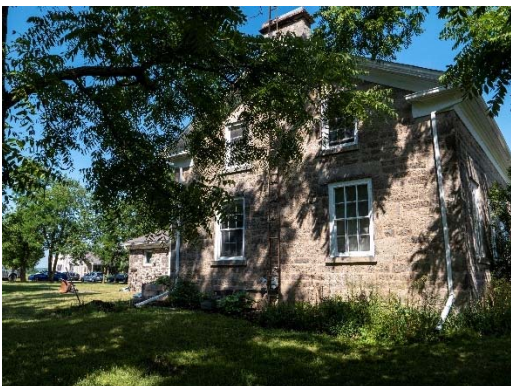
Figure 13: The south elevation mirrors the north elevation at the house's front portion.

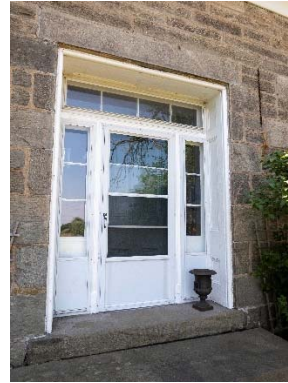
Figure 16: The main entrance door is recessed and set within sidelights and a transom.

The front (northeast) door is the most formal, recessed from the main wall and set within sidelights and a transom (Figure 16). The single door is the four-panel type, and it along with surrounding lights are protected by contemporary historic storm enclosures. All other exterior doors are simple rectangular openings sized to a single door.

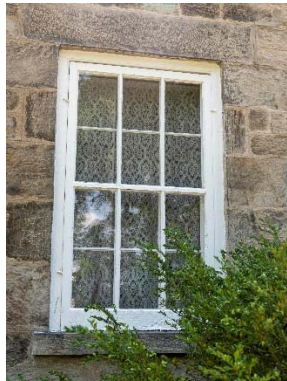
Figure 17: Typical historic window configuration on the north elevation, with six-over-six double hung sash covered by a storm window.

Windows are generally rectangular in proportion, with stone lintels and sills. They are double-hung sash windows, and many are historic boasting six-over-six arrangements and exterior wooden storms (Figure 17). Replacement windows are vinyl with false muntin bars repeating the historic pattern. Most basement windows have been blocked off in some fashion.

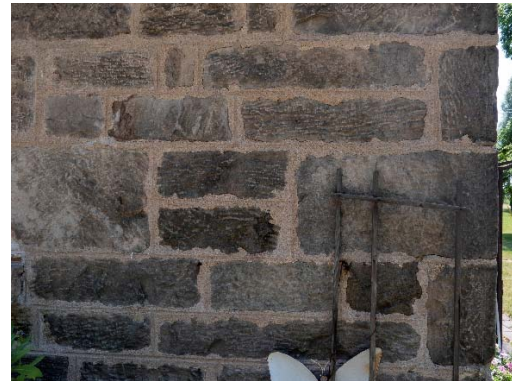
Figure 18: Typical masonry tooling, coursing and pointing as seen on the north elevation.

The house is constructed of an attractive grey-brown stone (Figure 18). Stone on principal and secondary elevations is laid in a coursed rubble pattern. Double-height stones are found at the (flush) quoining which corresponds to window and door jambs. On these elevations stone is roughly squared, and faced with a tooled surface that has eroded very little since the day it was carved. Lintels and sills are distinguished by a bush-hammered surface within tooled margins. Lintels over basement windows however are spared this detail. These walls are over pointed with a beige mortar with struck joints. Tertiary elevations are laid in a rubble pattern, with un-dimensioned masonry. Here stones lack a tooled surface and the pointing is not consistently struck. The house's masonry work was excellent and in-line with the high standards and techniques associated with the area's Scottish population.

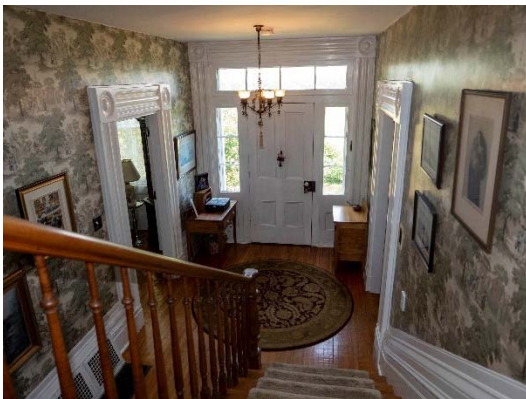
Figure 19: The main entry with doorways to dining (left) and living (right) rooms. The mouldings seen here are the most elaborate in the house.

The interior is arranged about a centre-hall plan. Two principal rooms are located at the front of the house just off the main entrance foyer, currently serving as living room (south) and dining room (north) (Figure 19). The staircase is located to the left, and the centre hall continues on the right leading to the kitchen within the rear wing. The main staircase features pine treads on painted risers embellished with string brackets. The railings, balustrades and newel posts are made from beautifully figured curly maple (Figure 20). Two secondary rooms along with a washroom and pantry are set behind the larger principal rooms. The kitchen occupies most of the rear wing, save for the former porch (now enclosed) and small laundry room in the rear corner (Figure 21). The second storey is accessed via half-pace staircase with six rooms located off a circulation corridor (Figure 22). These include four bedrooms, a washroom with separate closet, and walk-in closet. A number of partitions have been added to create the current layout of the second floor's south-east portion.<sup>12</sup> The basement is comprised of two large open spaces, one below the main portion of the house and the below part of the rear wing. Evidence of former plaster and lathe suggests the basement was at one time finished, and possibly from an early date given the irregular spacing of the lathework (Figure 23).

Door and window casings also vary in complexity according to formality, again based on a Grecian ogee. The most formal door casings are found in the first-floor hallway, with a symmetrical casing separated by corner blocks. The principal rooms are bold, with two built-up casings, a bead, applied Grecian ogee backband, and an outer border of torus (dining room) or cavetto (living room). These employ a double butt joint corner treatment. Others are simplified by omitting the outer border and second casing second. Door mouldings related to later partitions on the second storey employ an interior bevel on otherwise flat casing.

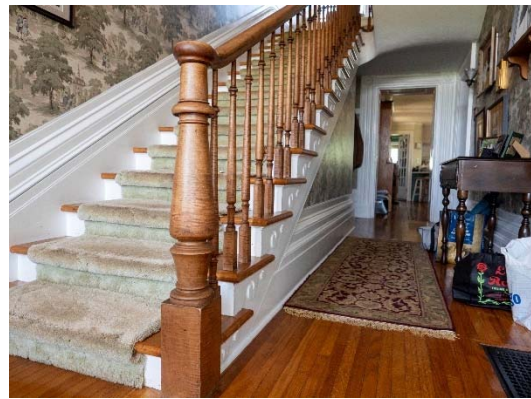
Figure 20: The staircase dominates the central hall with its prominent curly maple figuring.

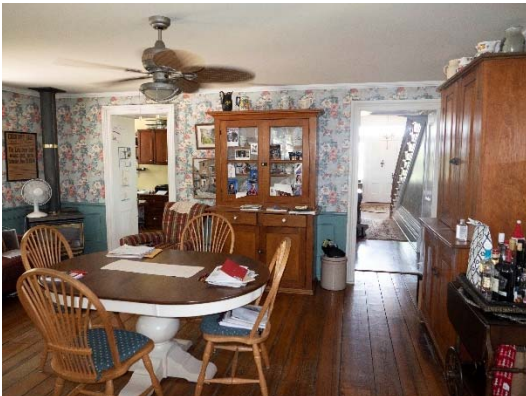
Figure 21: View of the kitchen looking east with the central hall and front door visible to the right.

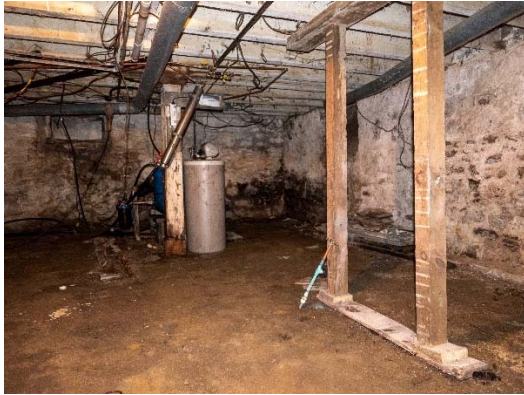
Figure 23: View northwest of the basement under the rear wing, with evidence of former plaster walls visible on remaining posts.

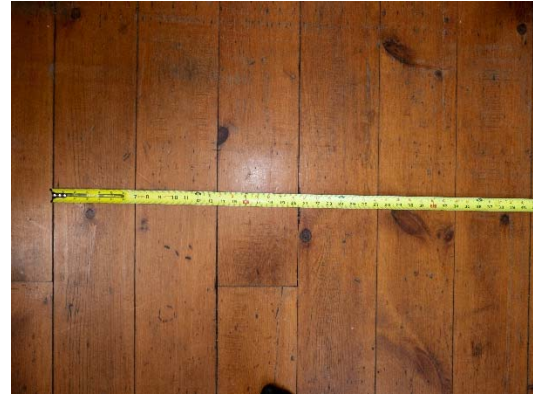
Figure 24: Pine flooring in the rear of the kitchen is of regular widths, unlike in other parts of the house.

Hardwood flooring is found throughout the first and second stories. In general, this is pine, in widths varying from 6¼" through 7½". Exceptions are in the kitchen, where varying widths of hardwood are used, and in the main hallway / dining room / living room where thin strips of oak have been added (Figure 24 & Figure 25). Wallpaper is used in both hallways, the kitchen, and first floor washroom, while other rooms are painted. A fireplace with pilasters supporting a classical mantle is located in the dining room.

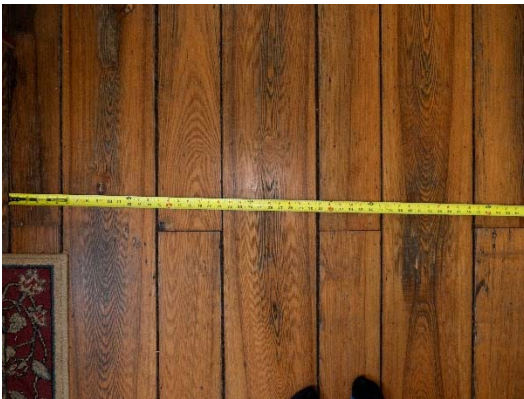
Figure 25: Hardwood flooring in the kitchen is of varying widths.

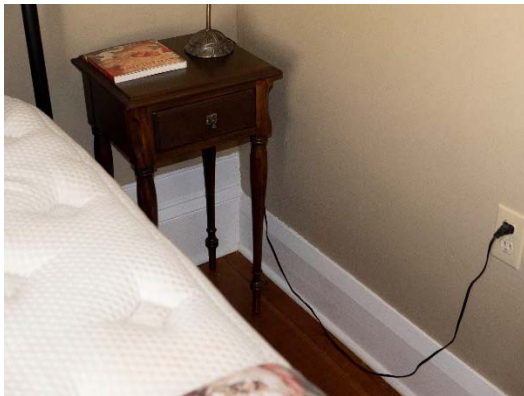
Figure 27: The northwest corner of the southwest bedroom shows where presumed original baseboards (left) meet those related to later partitions (right).

The farmhouse contains a high proportion of historic interior mouldings. All rooms feature baseboards and window / door casings, though crown mouldings are rare by comparison and unoriginal where extant. Baseboards are not found in the kitchen, dining room, and ground floor washroom where wainscoting is employed instead. Mouldings vary to create a gradient of formality in the house's spaces, with most variations based around a bevelled Grecian ogee (Figure 26). At least five baseboard types were identified, ranging from 18" tall using two ogees through a simple 7½" beaded board. Another simple baseboard adorned with a bevelled top is believed to correspond to later partitions on the second storey (Figure 27).

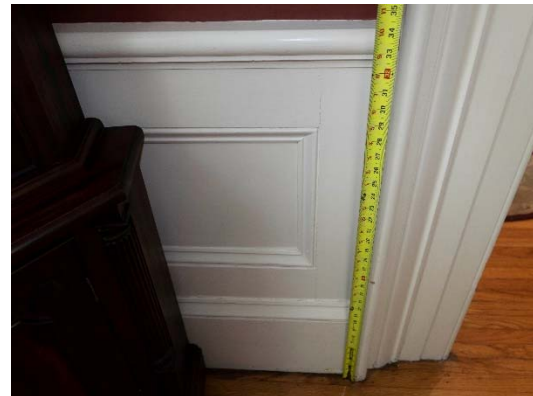
Figure 28: Typical wainscoting in the dining room is an embellishing version of that in the kitchen.

Wainscoting in the kitchen and dining room rises about 34" to a bullnose, and features flat panels with applied Grecian ogee mouldings (Figure 28). Washroom wainscoting is simpler, being vertically mounted boards separated by a bead. Panelling is also found within the splayed window recesses, and where doorways are set within the masonry walls. Some use applied mouldings while others feature raised panels instead.

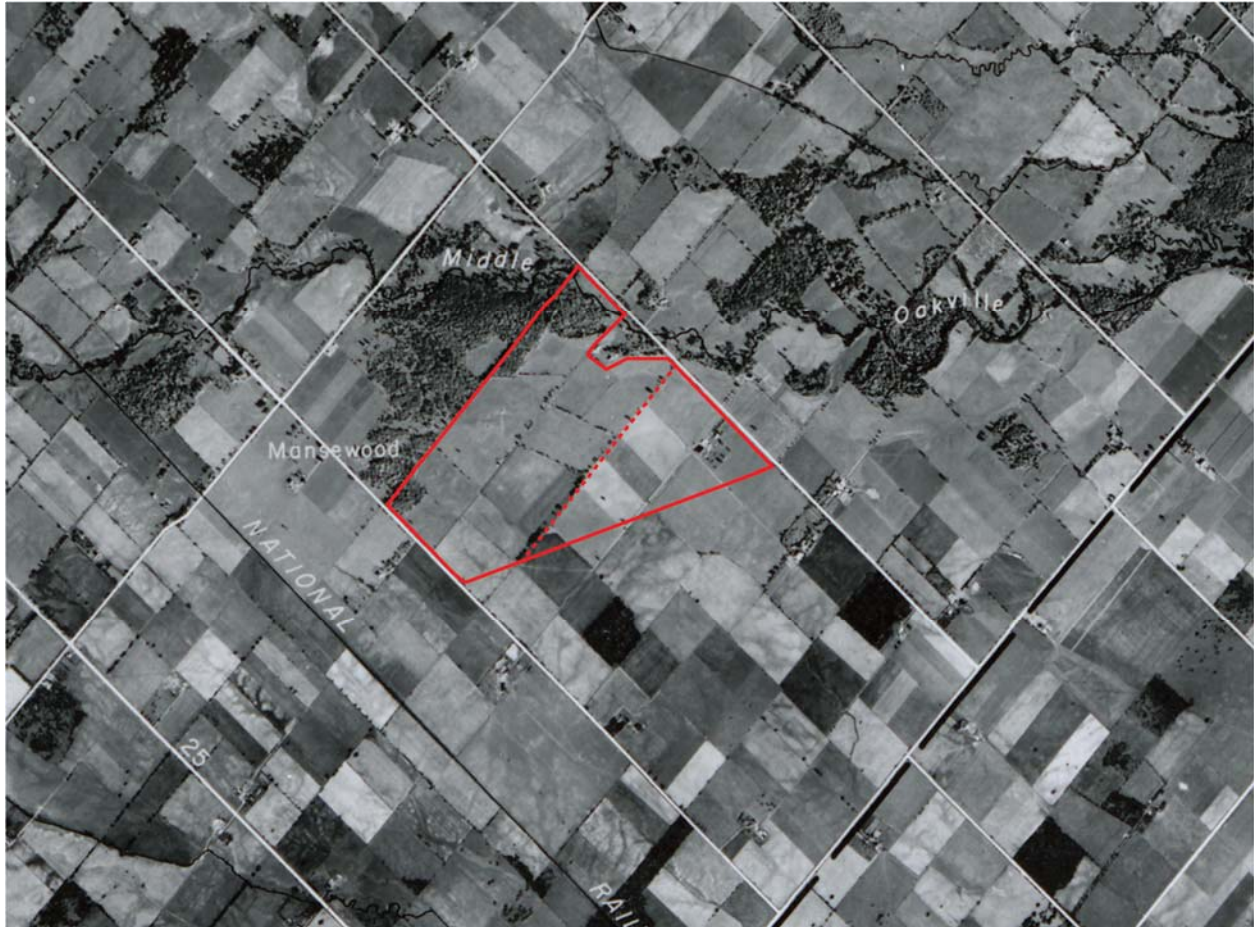
Figure 30: 1954 Aerial photograph showing the subject property (solid red line) with the boundary between lots 3 and 4 dashed. No shadows suggesting mature trees are visible on the main driveway (University of Toronto Map and Data Library / CBCollective 2020).

Aerial photography suggests that the trees lining the driveway were not fully mature until the mid-1950s (Figure 30).<sup>20</sup> The grain elevators and silos are first apparent in a 1985 aerial image, which corresponds to the addition of the driveway's southeast portion that created a continuous loop. The quonset hut appears is first seen on 1995 aerial images.

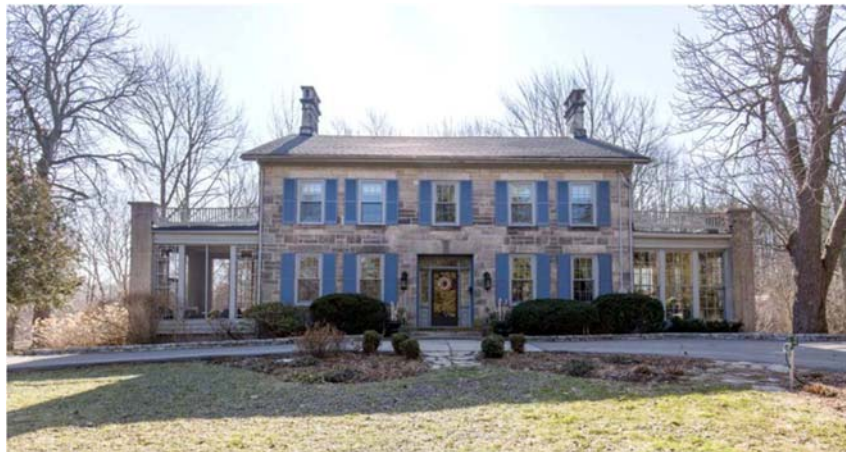
Figure 31: The central portion of Springdale (b.1810) outside Dundas, Ontario demonstrates the massing, form and composition typical of the Georgian style in Ontario. Incidentally the house employs a similar coursing to that of the subject property (Hamilton Built Heritage Inventory Form for 6 Webster's Falls Road, Flamborough).

Georgian architecture in Ontario is characterized by rectangular plans and massing rising to side gable or hipped roofs (Figure 31 & Figure 32). Principal facades are typically 3 or 5 bays, spaced evenly and symmetrically about a central doorway. Windows are usually double-hung sash set in rectangular openings lacking surrounds. Doors are also rectangular, often accentuated by sidelights or a transom. The decorative regimen is usually restrained, drawing on classical elements. Interior layouts are typically based on a centre-hall plan with a symmetrical layout of four rooms at grade, two on each side of the hall. Second floors often had two larger and two smaller rooms, again symmetrically arranged.<sup>22</sup>

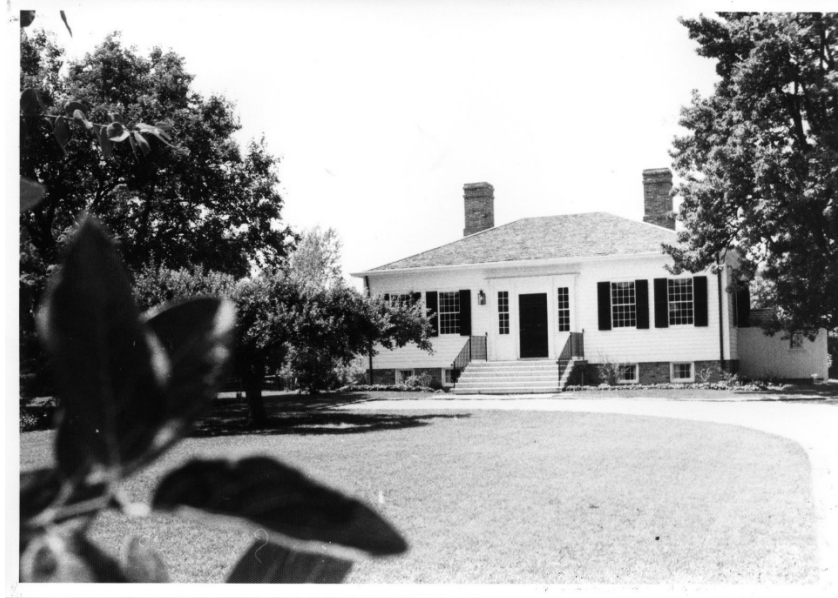
Figure 32: The Butler House in Niagara-on-the-Lake (b.1817) is an example of a one-storey Georgian composition, with corresponding basement windows as at the subject property (Niagara-on-the-Lake Public Library).

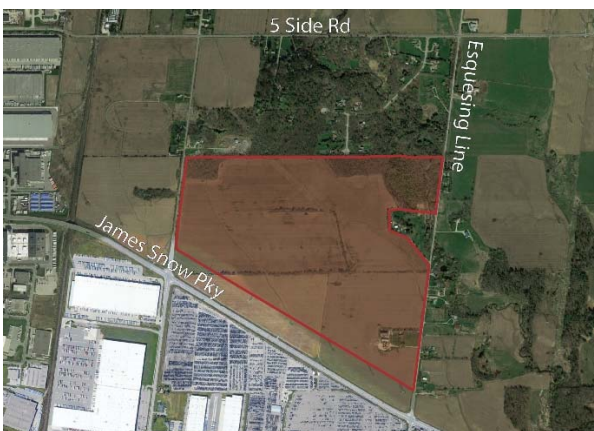
Figure 35: Aerial image showing Subject Property and setback of 8350 Esquesing Line (Google / CBCollective, 2020).

8350 Esquesing Line is comprised of an c. 1850 stone house of 1 ½ storeys with a one storey addition. The property also contains several 20th century outbuildings and structures associated with farming (Figure 35). The house is set back from Esquesing Line approximately 80 m and is accessed from the road via an unpaved, U-shaped driveway. The north side of the driveway is lined with mature trees. The outbuildings are compactly situated to the west of the house. The lands immediately to the west, north and south of the house currently in use as agricultural lands producing corn and soy beans. The house is visible from the road if you are approaching from the south, but if approaching from the north in the summer the row of trees obscures the view of the house.

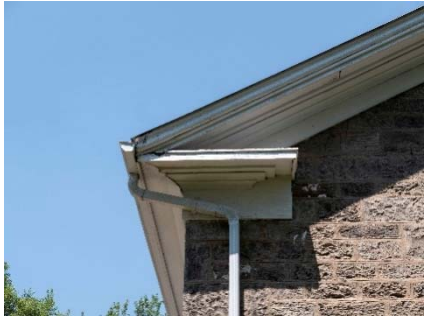
<b>Drainage</b>	
<p><i>Description:</i>                  Externally mounted aluminum eaves and downspouts used on both front portion and tail addition. Eaves are mounted onto fascia boards.</p> <p><i>Condition:</i>                  Eaves and downspouts are in good condition and functioning well, generally discharging water well clear of the walls or into receptacles.</p>

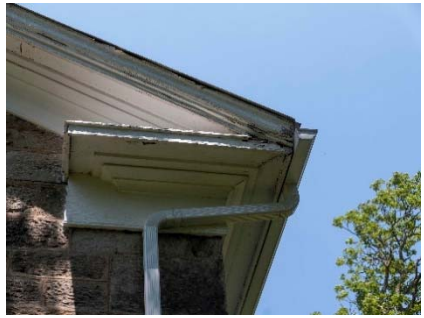
<b>Fascia &amp; Soffit</b>	
<p><i>Description:</i>                  Wooden fascia / soffit boards and mouldings are used throughout. Fascia boards are large and adorned with a bead with soffits flat. Both are embellished with bed mouldings and crown mouldings are added at the gable ends.</p> <p><i>Condition:</i>                  Wood elements are in fair to good condition throughout. Some instances of paint failure were observed, showing evidence of rot in areas of more advanced deterioration. The south and west sides of the front portion of the house displayed the worst conditions.</p>

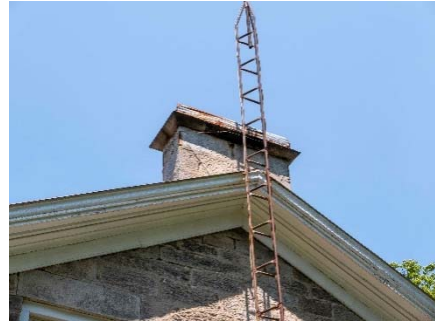
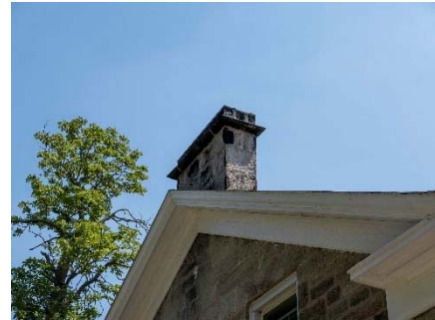
### Chimneys

The masonry is in fair condition, displaying heavy black soiling on the north chimney and rust staining on the south. Some joints have failed and others repointed, but no obvious dislocation of masonry units was observed. Galvanized coping on the south chimney is rusting badly.

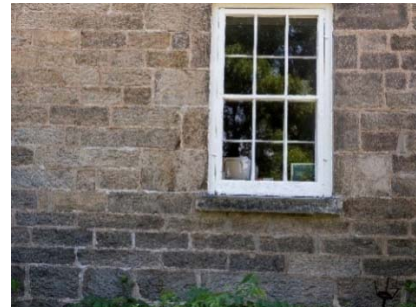
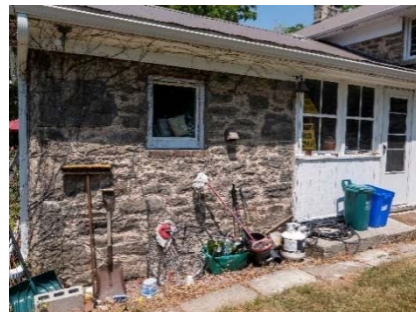
## 6.2 WALLS

Sandstone units are in good condition throughout, showing few instances of cracking, erosion or delamination. Projecting sills display occasional cracking. Some black staining was observed. The wall assembly is also in good condition, with no large areas of zipper cracks in joints observed. In a number of areas repointing has been carried out with mortars that are visually and physically incompatible.

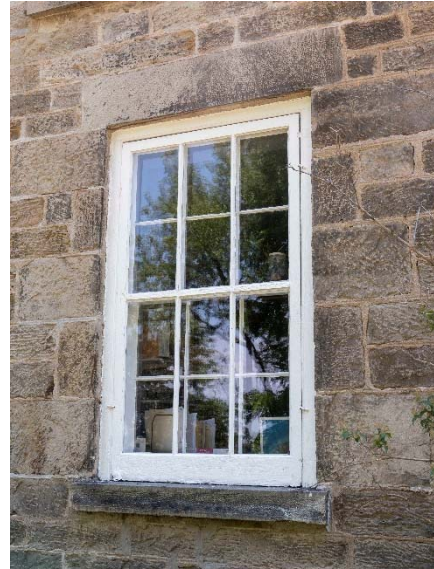
## Windows

Historic sash and storm windows are in fair to good condition and appear well-maintained. Paint and putty are generally sound throughout, with deterioration most advanced on the south elevation. One window beside the north kitchen door has been modified by a muntin bar removal. Wood was not tested for rot.

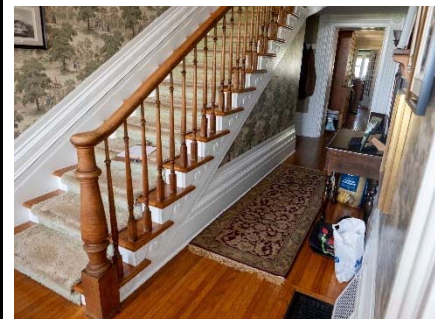
## Balustrade

The balustrade is in good condition throughout.

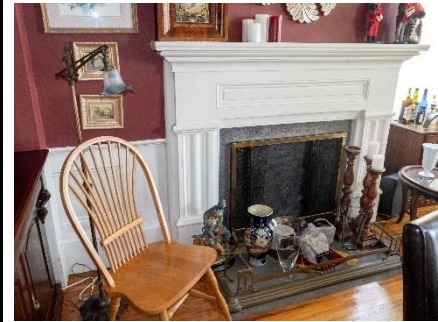
## Fireplace

Both wood and masonry components are in good condition.

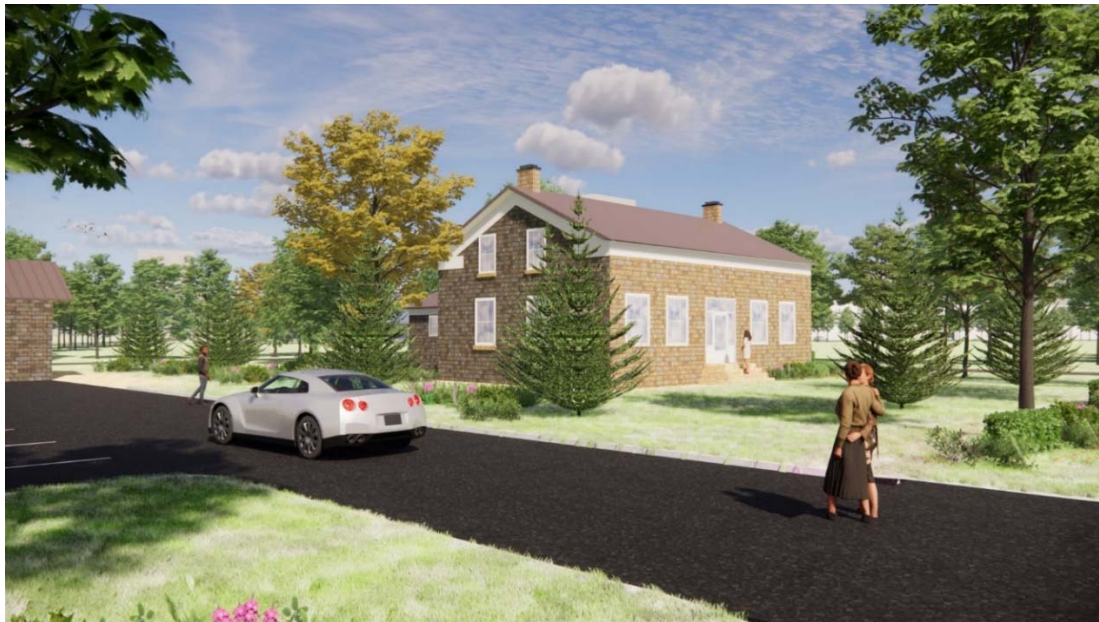
Figure 40: Perspective view, conceptual, of the relocated heritage house in the proposed new development as seen from the intersection of James Parkway and Esquesing Line. (Orlando Corporation 2021)

The proposed new parcel for the relocated heritage house is close to its original location which helps preserve its context. The house will enjoy a prominent location at the intersection of James Parkway North and Esquesing Line on a corner lot, ensuring visibility from the public right-of-way (Figure 40) and will also maintain its existing visual relationship with Esquesing Line.
