Report No: DS-109-22

Subject: Recommendation Report _Objections to the Designation of 111 Mary Street (Edwin Earl House)

**Edwin Earl House
111 Mary Street
Milton, Ontario**

Heritage Impact Assessment

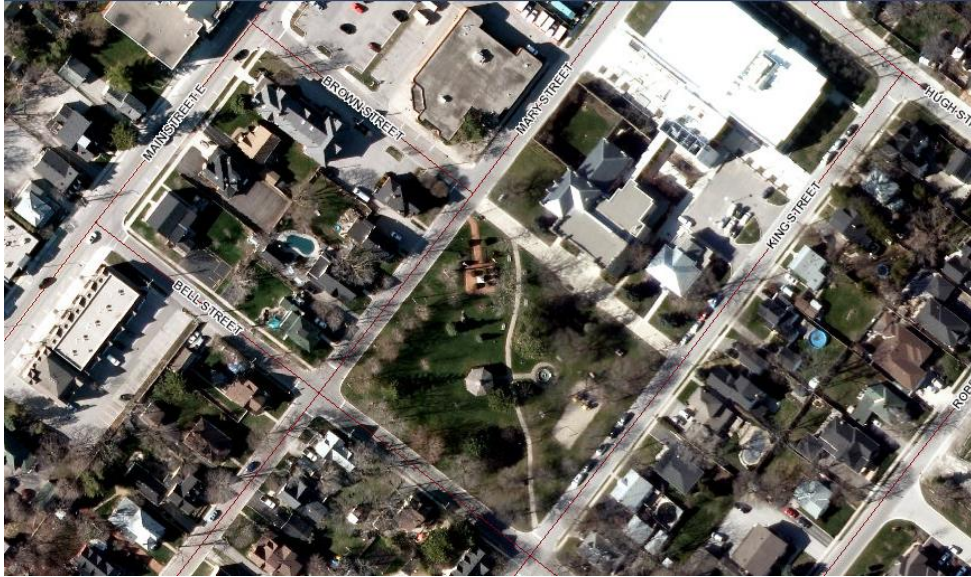
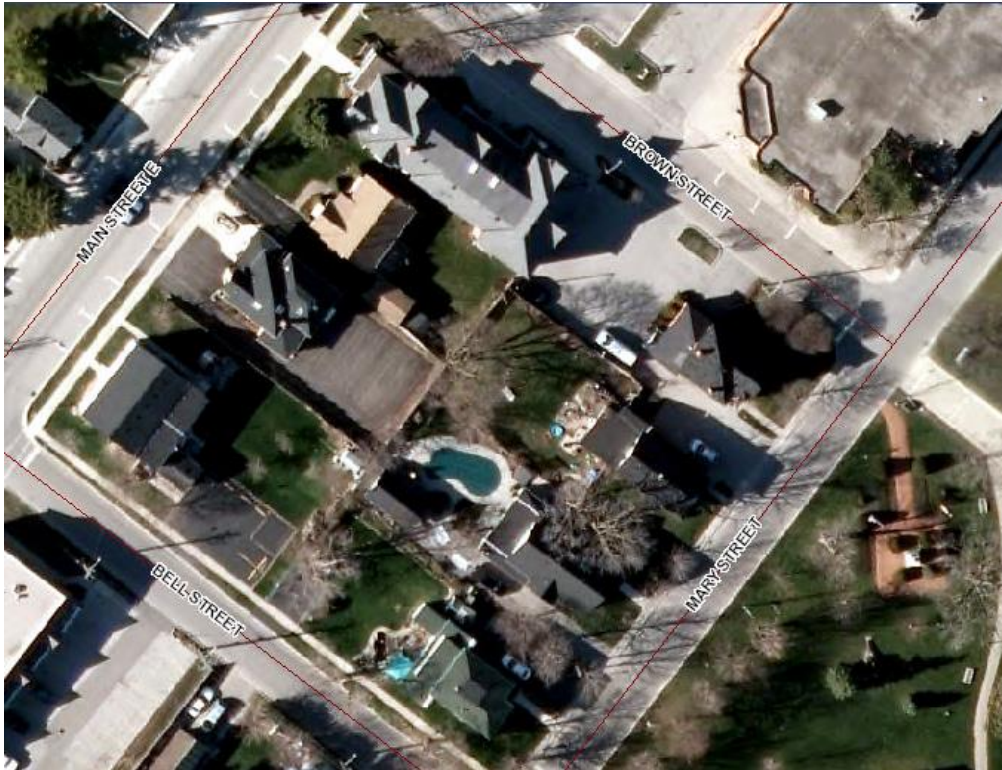
Figure 3 – 2103 Air photo. (Image source: Town of Milton GIS, accessed July 2014)

Figure 4 – 2103 Air photo. (Image source: Town of Milton GIS, accessed July 2014)

The subject property is within what is known in the Town of Milton Official Plan as “Old Milton” and is one of the original 19th century, Victorian homes built to front onto the northwest side of what was originally Court House Square (now Victoria Park) (Figure 1). The property is known legally as Lot 3 in Block 7 of Plan 7 (Foster’s Survey) and the parcel was surveyed in 1992 as shown in Figure 2. The present day context is seen in the 2013 air photo shown in Figures 3 and 4.

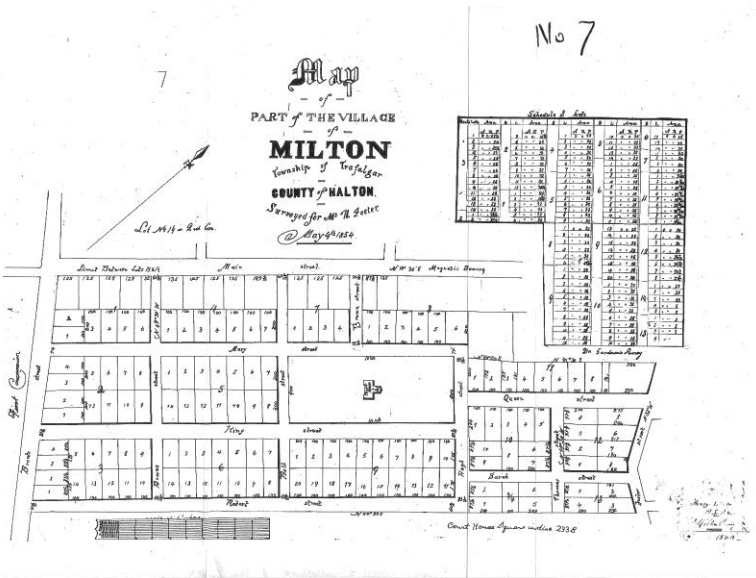
Figure 8 – Milton Registered Plan 7, 1854.
Henry Winter, P.L.S.
(Image: Halton Land Registry Office)

This registered plan became commonly known as “Foster’s Survey” (Figures 8 and 9). The real property at 111 Mary Street (formerly West Mary Street) has cultural heritage value as it is a parcel established in the original survey and subdivision of this area of the Town of Milton.

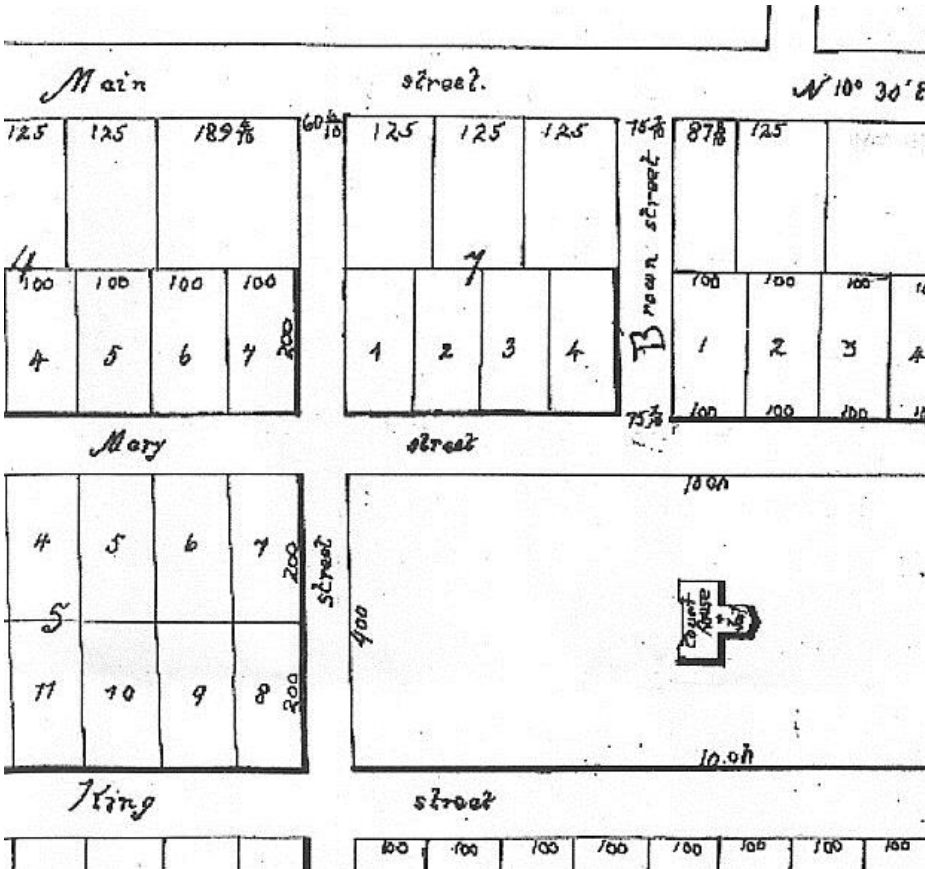
Figure 9 – Detail of Milton Registered Plan 7, 1854. Henry Winter, P.L.S.
(Image: Halton Land Registry Office)

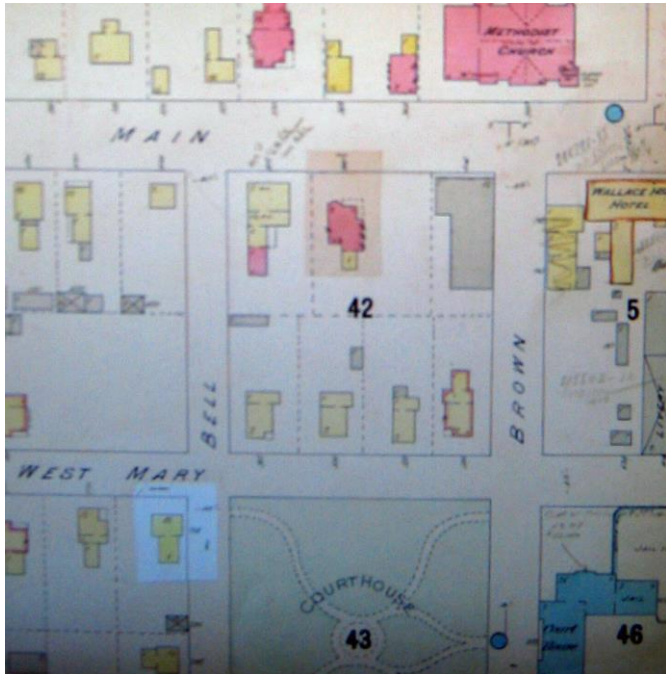
Figure 15 – Charles E. Goad, *Fire Insurance Plan for the Town of Milton*, May 1893 (Sheet 3). (Image: Gore Mutual Archives, Cambridge).

Goad's 1893 Fire Insurance Plan for the Town of Milton (Figure 15) indicates Lots 1, 2, 3 and 4 in Block 7 of Plan 7 with dwellings facing Court House Square (now Victoria Square). Lot 3 shows a 2-storey, wood frame house with a wood shingle roof and a footprint similar to the existing house at 111 Mary Street. It should be noted that porches are indicated on the dwellings at what are now 117 Mary Street, 99 Mary Street and 100 Main Street East. No front porch (open or enclosed) is indicated on 111 Mary Street but the front façade is indicated as protruding well past that of 117 or 107 Mary Street. Therefore, it is possible that the enclosed upper storey of the front porch is shown as an extension of the main floor footprint without indicating the open main floor porch beneath, similar to the house today indicated on the surveyor's plan in Figure 2. No bay window is indicated on the southwest wall of 111 Mary or on the front of 107 Mary Street.

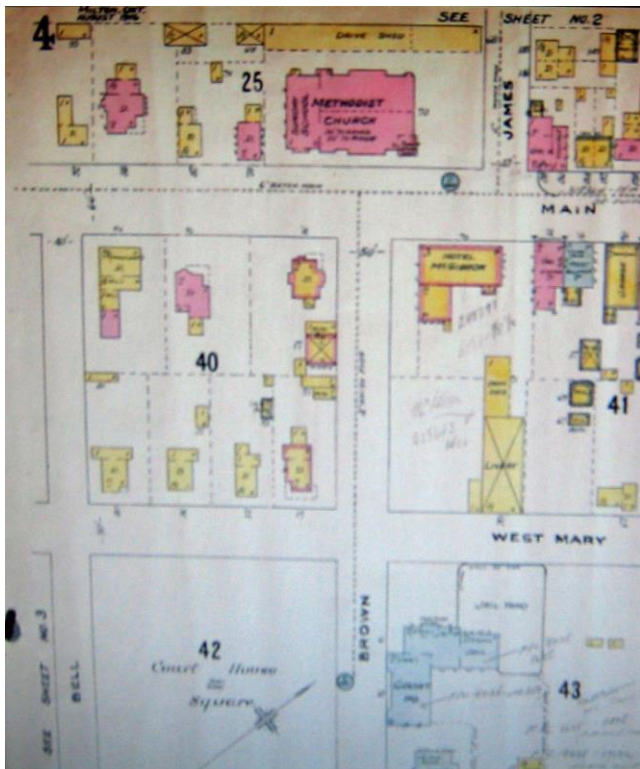
Figure 16 – *Lloyd's Insurance Survey of Milton, Ontario*, August 1916 (Sheet 4). (Image: Gore Mutual Archives, Cambridge).

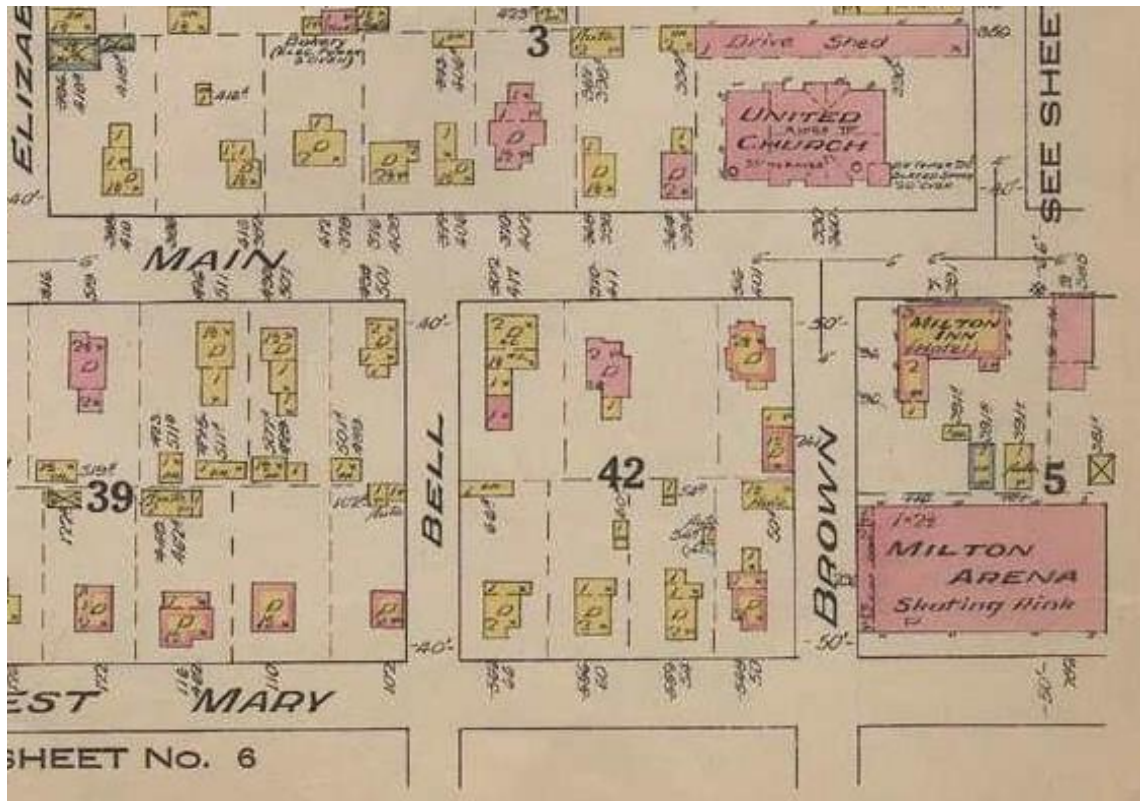
Figure 17 – Fire Insurance Map of Milton, Ontario. 1927 (Sheet 6).
(Image: Milton Historical Society webpage accessed 15 July 2104)
<http://www.miltonhistoricalsociety.ca/the-archives/fire-insurance-maps/>

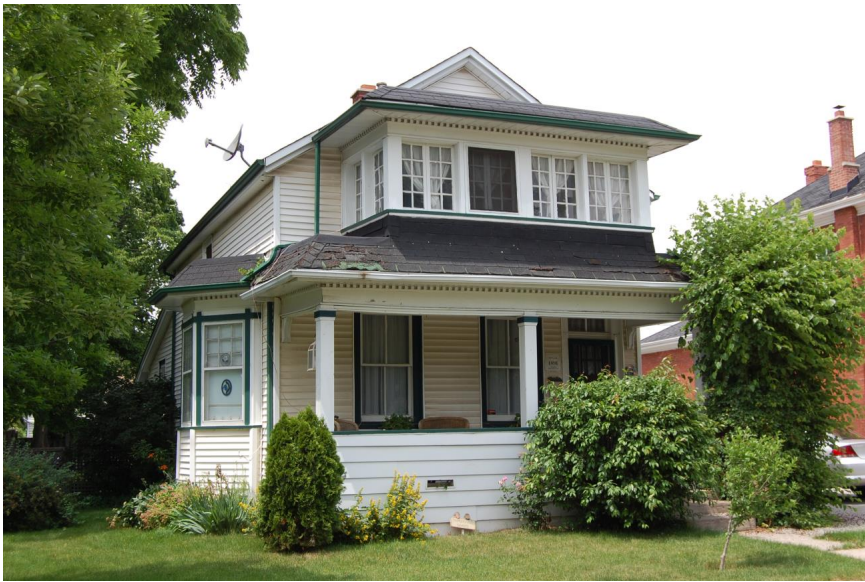
Figure 18 –

View from south

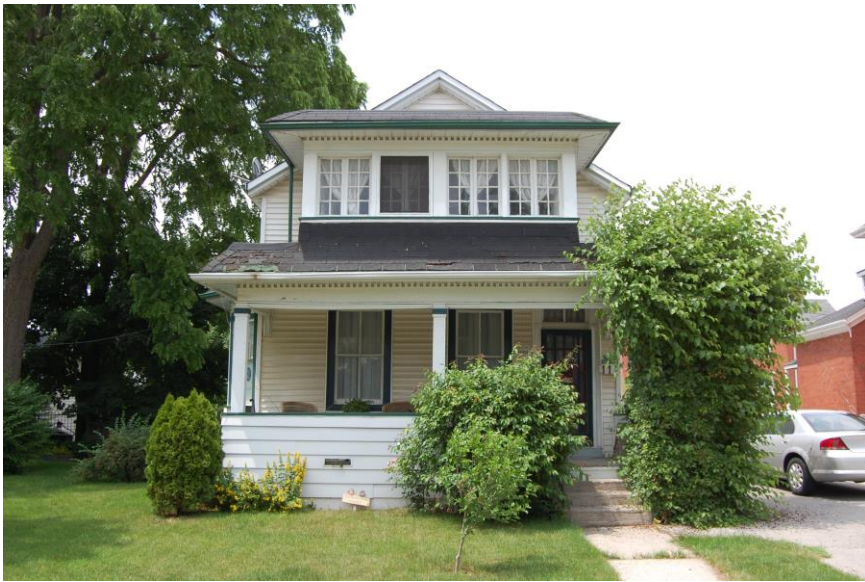
Figure 19 –

Front facade

The subject dwelling is a 1.5-storey, front gable house built in wood frame construction on a rubblestone foundation – originally with no basement other than a crawlspace. The medium pitch, front gable façade is in Greek Revival style - 3 bays on the main floor with the front door on the right similar. This style of house design was popular in the mid-19th century Ontario architecture and is also seen in contemporary houses at 101 Main Street East and 80 Robert Street (Figures 143a and 143b). The main roof of the subject property now has a rug brick chimney shaft rising from the centre of the ridge. The house has been more recently been clad in vinyl siding that mimics a medium width horizontal clapboard siding.

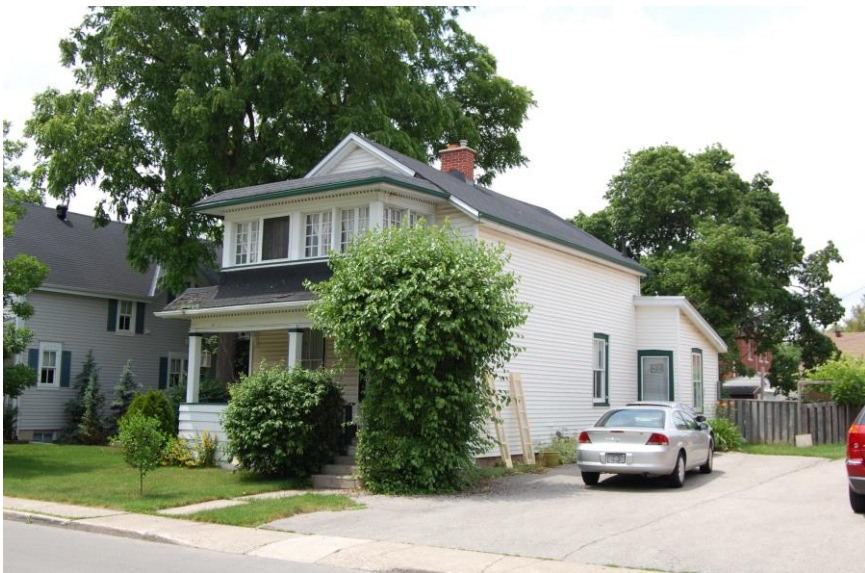
Figure 20 –

View from south
