Report No: PD-046-19

Subject: Heritage Designation of the Bowes House, 1335 Basswood

HERITAGE IMPACT ASSESSMENT

Report Number: 1211360042-2000-R01

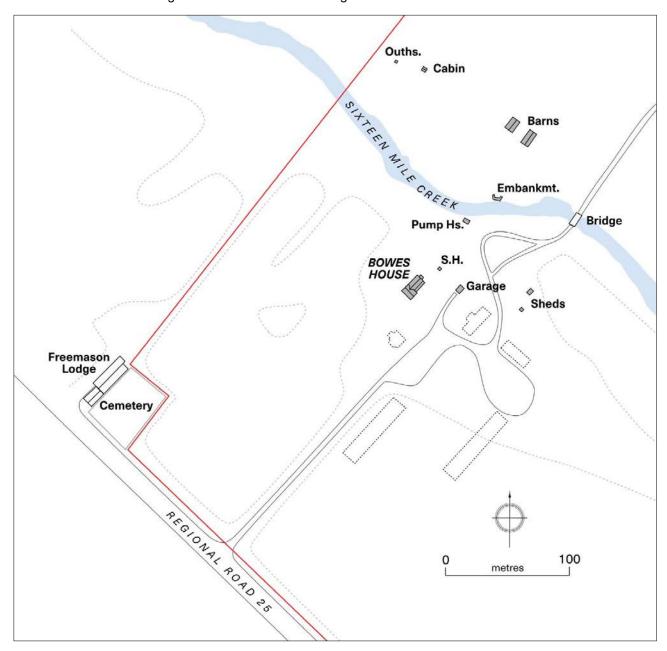
Figure 10: Key plan of elements in the Study Area (west half).

The elements in the following sections are illustrated in Figure 10.

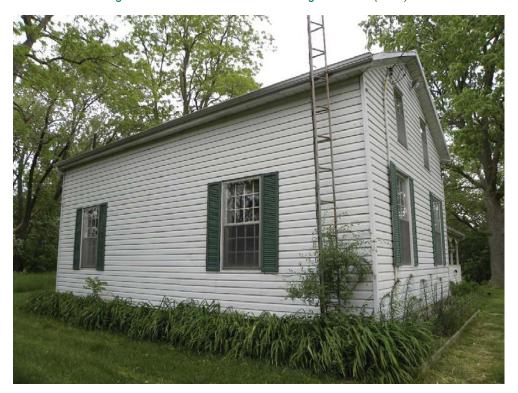
Figure 20: South and east façades of Bowes House (2012).

Except for the pairs of tall windows in gables, fenestration is asymmetrical throughout. On the east end wall the two tall windows are not placed equidistant from the corners and are not symmetrically placed beneath the windows of the gable (Figure 20). On the south facade, the west window is slightly nearer the corner of the building than the window to the east, while on the west end wall there is only a single, tall and narrow window on the south side that is slightly offset from the gable window above. The other window of the west end wall is placed nearer the north wall, is short, and now blind (Figure 21). All windows are wood, six-over-six and double-hung with metal storms and lack sills (Figure 37 and Figure 38). The main floor windows on the south facade and east end wall also have decorative shutters. Entrance to the main block is only through the interior of the north wing, and off-set to the east and west.

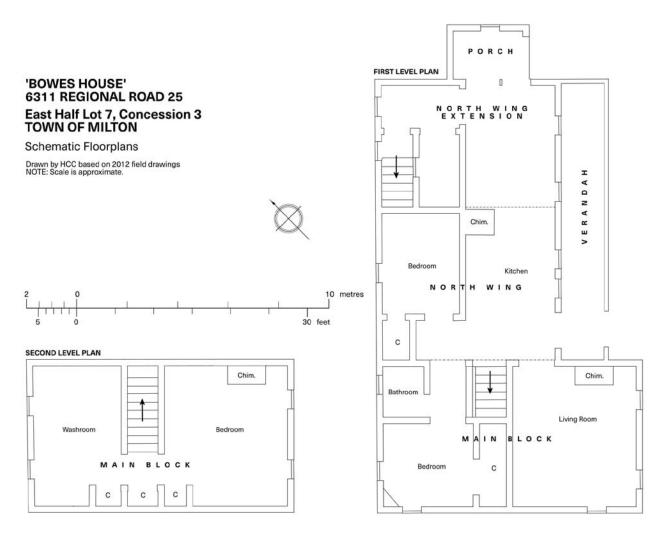
Figure 27: First and second level schematic floor plans of Bowes House.

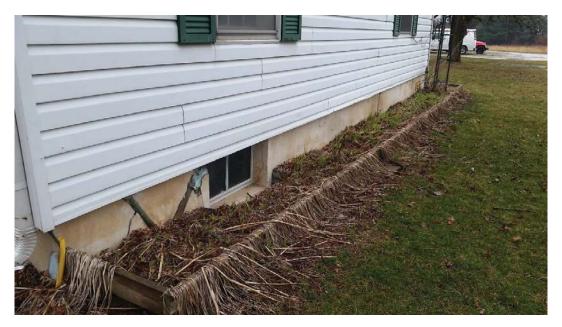
Figure 28: Portland cement parging on the south foundation.

The full-height, below ground level foundation is presumed to be stone but is parged in a thick application of Portland cement on both the interior and exterior (Figure 28). Above this the walls are clad in vinyl siding with narrow corner boards. On the southwest corner this siding extends a few inches from the end wall and gable, indicating the possible location of an external chimney, since removed (Figure 35). Apart from this unusual cladding section, there are no other wall details.

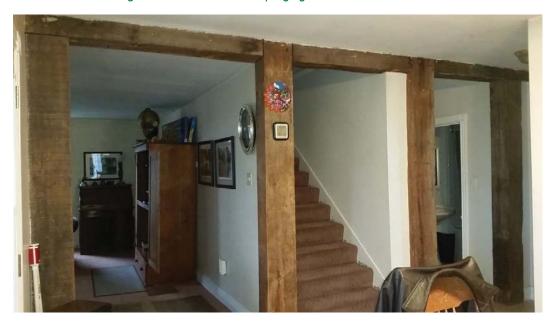
Figure 29: Exposed timber framing on the north wall of the main block. The load bearing posts of two bents are either side of the stairs, while at each end are non-load bearing vertical studs. Three cross braces run across the ceiling.

From the exposed wood posts seen on the interior, the walls are known to be heavy timber frame (Figure 29 to Figure 32). Armstrong, Molesworth Sheppard Architects Limited (2010) believed these exposed elements to be decorative since they did not appear to be load bearing but this is only partially correct; the one-and-a-half storey timber framing as seen at Bowes House involves a series of 'bents' created from load bearing vertical members on the north and south walls that terminate with a plate at the top of the second level knee-wall. Joined with mortice and tenons lower down the vertical members are north-south running beams that support the second level floor (Figure 33 and Figure 34). Within and between each bent are cross braces that do not bear loads but are used to frame outer walls, interior partitions, doorways, and windows.

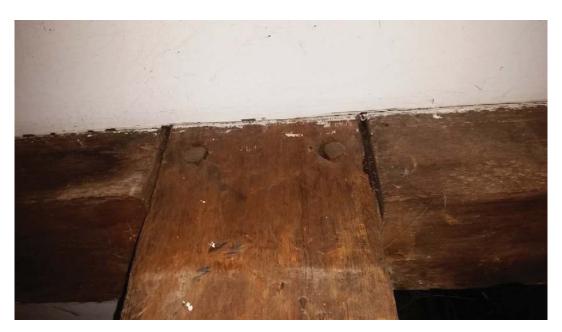
Figure 30: Principal post for a central bent, morticed and pinned to cross-braces.

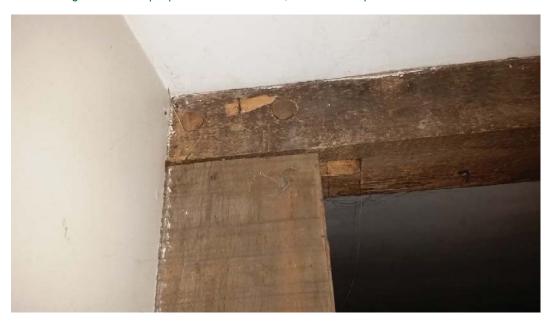
Figure 31: Vertical stud pinned to a cross brace.

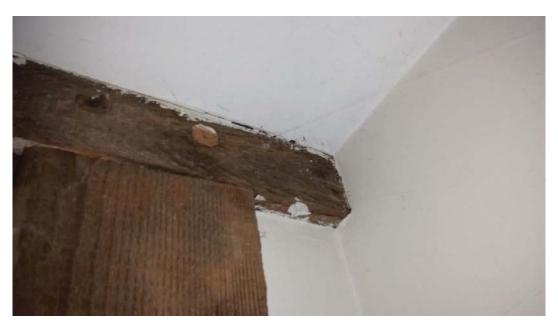
Figure 32: Vertical stud pinned to a cross brace.

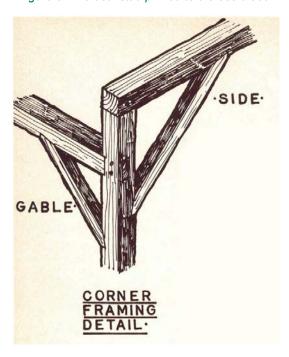
Figure 33: Possible framing technique used at Bowes House, where the posts of the 'bent' are load bearing and the plates are either at the top of the kneewall ('side') or support the floor ('gable') (from Rempel 1967:108). Partitions and wall sections within this framing were formed from non-load bearing vertical studs and cross-braces.

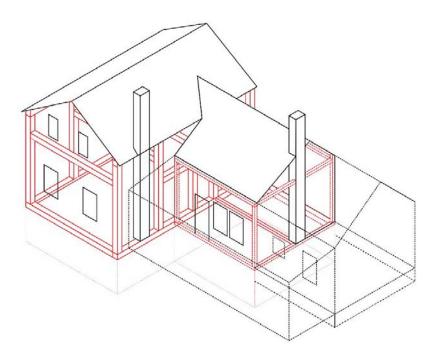
Figure 34: Axonometric rendering of Bowes House showing the possible timber-framing of the main block and north wing. The framing of the north wing is conjectural except for the floor beam and foundation, which were noted during field investigations.

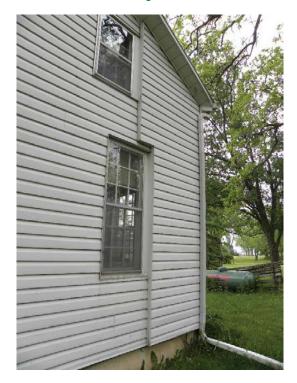
Figure 35: Possible remnants of an external chimney on the southwest corner of the main block (2012).

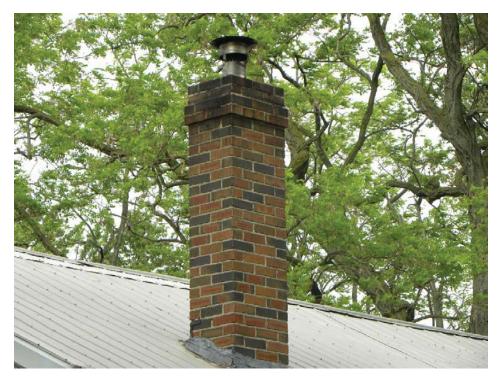
Figure 36: Main block chimney stack (2012).

The main block has a single stack, off-set front chimney with metal lining extending from the north-facing slope of the roof near the northeast corner (Figure 36). Although tall and with a simple crown it appears from the random dichromatic brick construction to be a late 20th century addition.

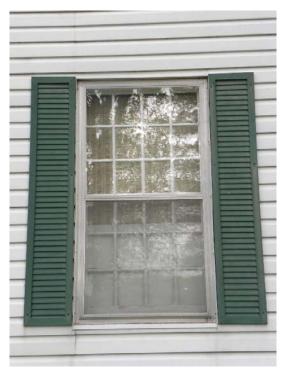
Figure 37: Typical ground floor window on the main block (2012).

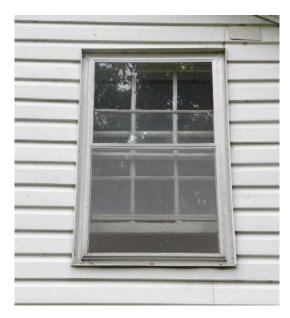
Figure 38: Typical second floor window of the main block (2012).

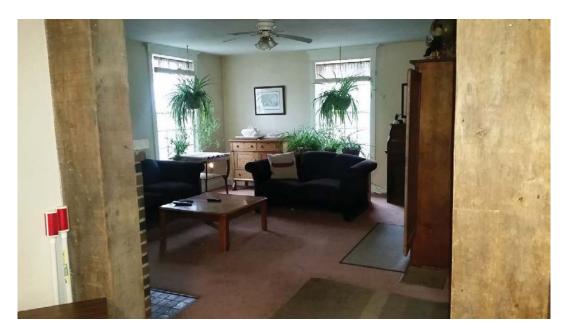
Figure 39: View of the main block living room, facing south.

The first level of the main block is divided into three rooms, two closets and the staircase to the second level. On the east side of the main block is a large living room entered from the north wing through a breach framed by exposed timber-framing (Figure 39). In the north wall of this living room is a late 20th century fireplace, which is constructed in same dichromatic, decoratively 'overfired' brick seen on the main block chimney (Figure 40). The walls and ceiling of the living room appear to be plasterboard and all skirting boards are late 20th century prefabricated moulding. The window architraves appear to be early 20th century in date and have crown mouldings and frieze boards, stools and aprons, and fluted casings.

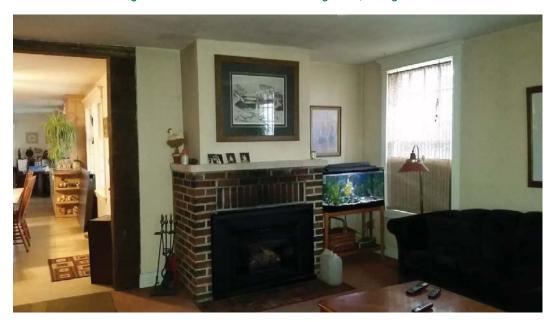
Figure 40: The northeast corner and fireplace of the main block living room.

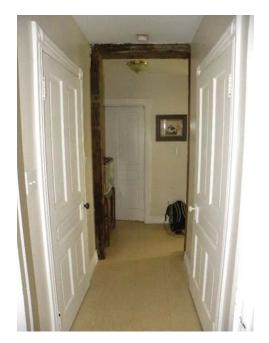
Figure 41: Hall west of the central staircase, facing north.

Centred on the north wall within the north wing is the narrow straight staircase, which is partially framed by exposed timber frames, but also by a partition wall (Figure 41). The staircase lacks decoration except for a visible string and moulding at the second level floor.

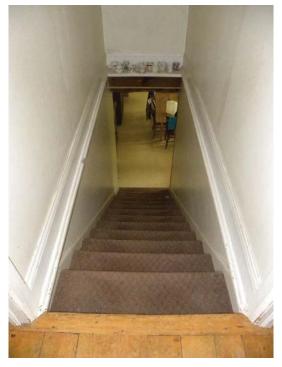
Figure 45: Main block staircase, facing north.

At the top of the straight stairs is a small landing that leads to a bedroom on the east, and a large washroom on the west (Figure 45 to Figure 50). These rooms are only full height at the centre of the room, and the ceilings descend to a kneewall on the north and south sides. Much of the original wall plaster, north-south running floorboards, tall and plain skirting boards and architraves appears to be intact in the bedroom and washroom, with the exception of a number of newer partitions in the washroom. Interestingly, architraves in the bedroom are simple in form, while the washroom architraves have the same corner rosettes as the first level bedroom.

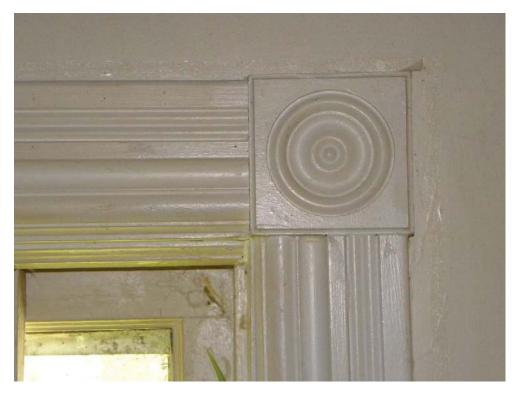
Figure 49: Detail of a rosette on a second level door architrave.

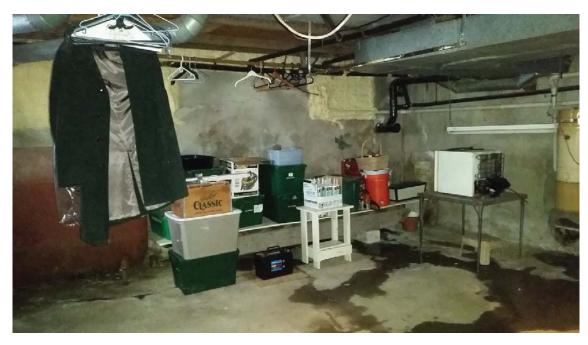
Figure 51: Portland cement parging and poured concrete floor in the main block basement.

Accessed via the north wing, the basement of the main block has walls parged in concrete and a poured concrete floor (Figure 51). A masonry support for the brick chimney is under the living room, and there is a blind access to the exterior or coal chute in the centre of south wall. The floor joists, which are consistent dimensions and appear to have been planed, run north-south, while the floorboards above, which also appear to be planed and lack shims, run east-west (Figure 52). Only the north wall sill is visible, and is hand-hewn squared, and notched to receive the ends of the joists (Figure 53).

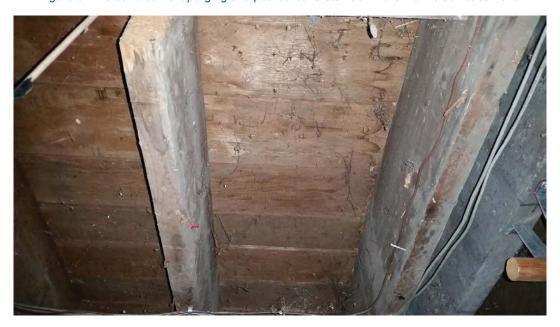
Figure 52: Joist and floorboard construction as seen from the main block basement.

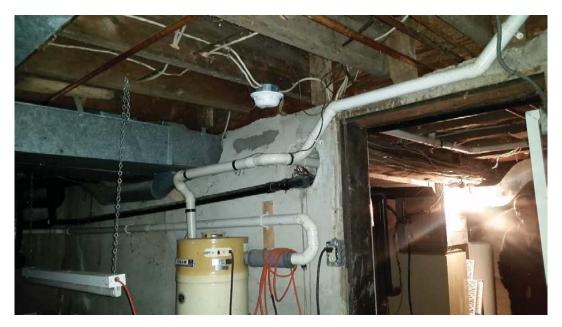
Figure 53: Joists running to the hand hewn sill on the north wall of the main block.

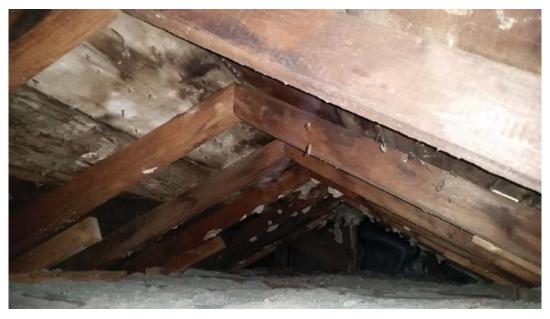
Figure 54: Roof construction of the main block as seen from the attic access.

Access to the attic is in the ceiling of the east second-level bedroom and is a low space with minimal insulation. The roof structure involves only simple and wide band-sawn common rafters (some of which appear to have been sistered) sheathed in a combination of both narrow and wide planks, and joined at the peak with only a simple top cut (Figure 54).

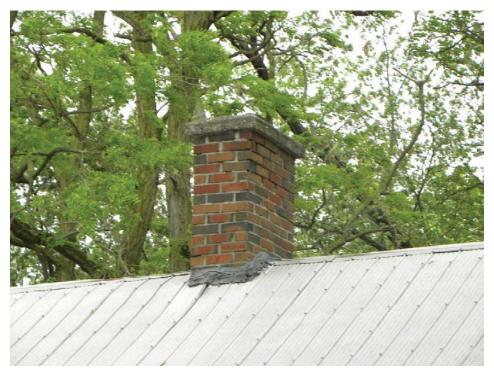
Figure 55: North wing chimney with concrete cap (2012).

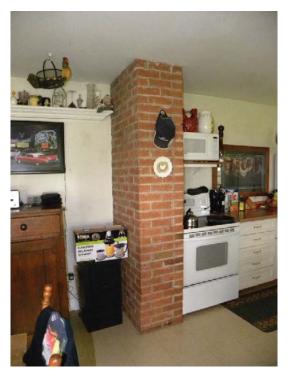
Figure 57: Exposed stack in the north wing kitchen.

light red brick laid entirely in stretcher course with wide mortar joints, and extends into the central partition (Figure 57).

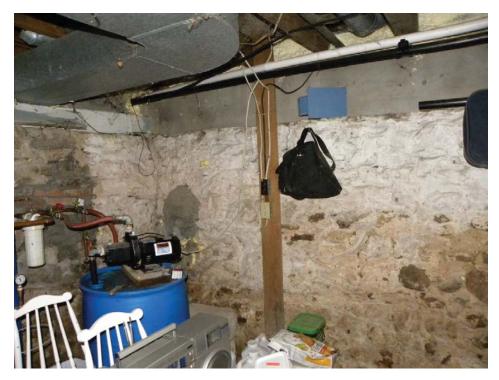
Figure 60: Coursed rubble foundation in the north wing basement.

The basement for the north wing is entered through the north wing extension, and has a poured concrete floor (Figure 59 and Figure 60). The coursed and whitewashed rubble of the north, east, and west walls are exposed, as is a large north-south running and hand-squared beam supporting the centre of the east-west running floor joists (Figure 61). The joists are a consistent dimension and appear to have been planed, while the floor boards above, which run diagonally northeast-southwest may be band sawn (Figure 62).

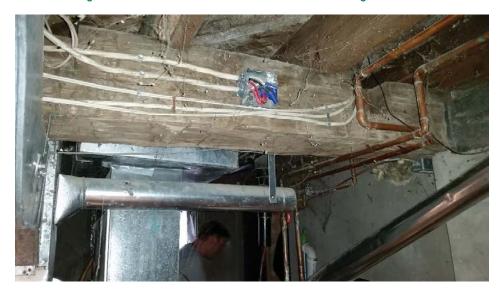
Figure 61: Hand hewn beam in the north wing basement.

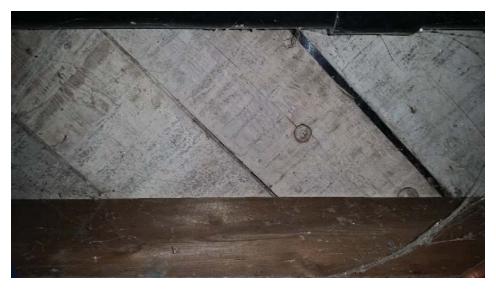
Figure 62: Diagonal flooring as seen from the north wing basement.

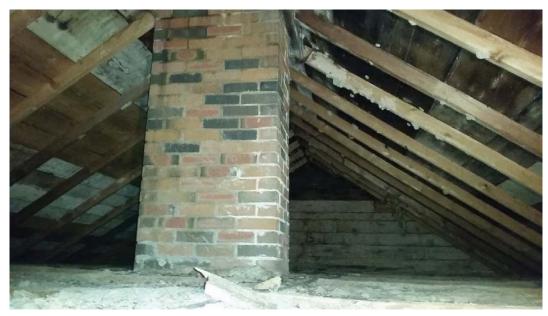
Figure 63: Roof construction and chimney stack in the north wing attic.

Access to the attic is via a storage room in the north wing extension. From here can be seen the chimney stack above the ceiling level constructed in the same overfired brick as above the roof line, and that the roof is constructed for both the north wing and north wing extension as common 2-by-4-inch pressure treated rafters nailed to a ridge board and sheathed with wide boards (Figure 63). Some of latter have been recently replaced. At the junction with the main block is a wall of horizontal plank sheathing (Figure 65).

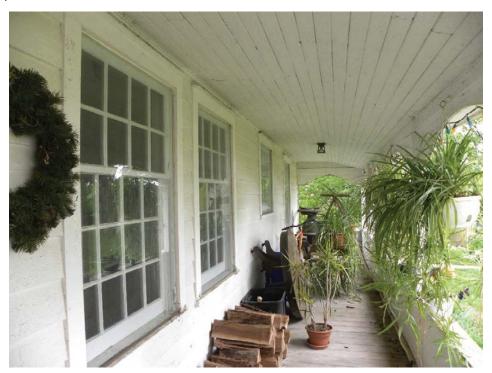
Figure 64: View of the verandah, facing north (2012).

The open verandah that runs the east length of the north wing and north wing extension has a close railing and covered by a shed roof attached to the eave of the wing. Tongue-and-groove narrow planking running north-south forms the slightly angled ceiling of the verandah, while the decking is wood plank laid east-west (Figure 64). At the top of the plain posts is thin curvilinear cut board used as decoration.

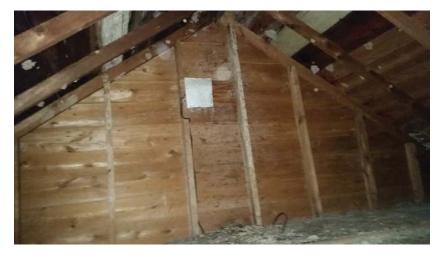
Figure 65: Plank sheathing in the gable of the north wing extension.

As mentioned above, the kitchen space of the north wing extends into the extension and includes the French doors of the north end wall. The remainder of the space is divided into a storage room (with access to the attic), laundry room, and stairs to the basement. Beneath the extension is inaccessible crawlspace but believed to be poured concrete foundation, and in the attic above is roofing constructed with common 2-by-4-inch rafters with ridge board, new and old plank sheathing, and an end wall constructed of vertical 2-by-4 inch studs and horizontal board sheathing (Figure 65).

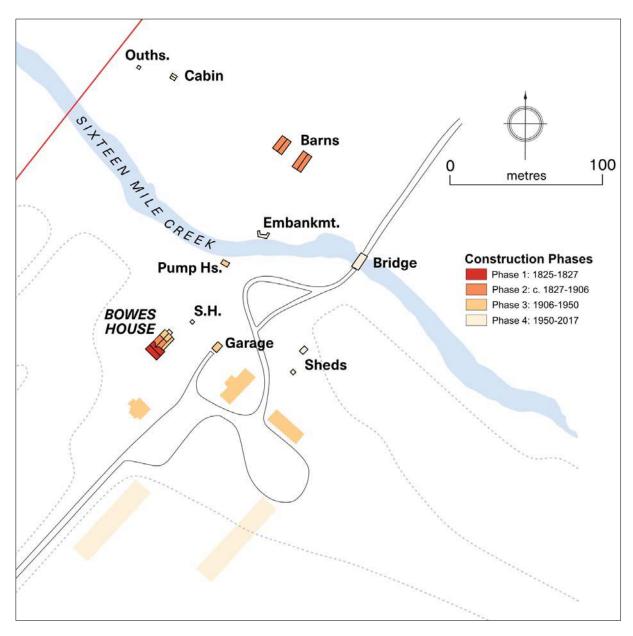
Figure 66: Structural phases identified in the Study Area.

Despite the early date of construction of Bowes House, and the Study Area's continuous occupation to the present day, only four structural phases could be identified in the structural evidence. These represent the initial construction (Phase 1, c.1825-1827), the Bowes occupation to 1906 (Phase 2, 1827 to 1906), the Lawrence to Martin occupations between 1906 and 1950 (Phase 3, 1906-1950), and the Martin occupation until the present day (Phase 4, 1950-2017). Each are described below and visually summarized in Figure 66 and Figure 67.

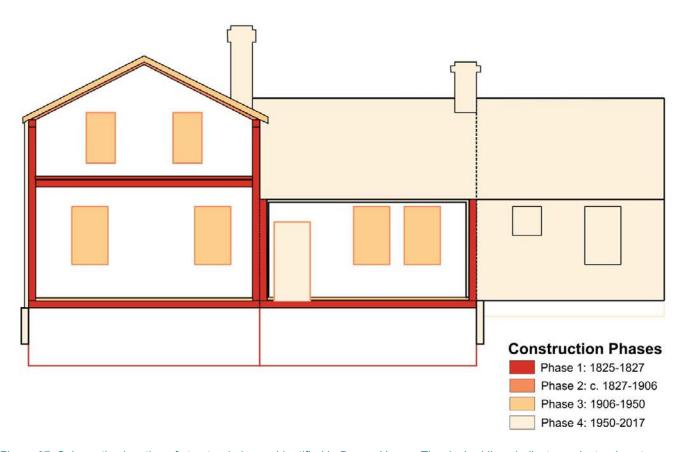
Figure 67: Schematic elevation of structural phases identified in Bowes House. The dashed lines indicate conjectural posts or divisions.

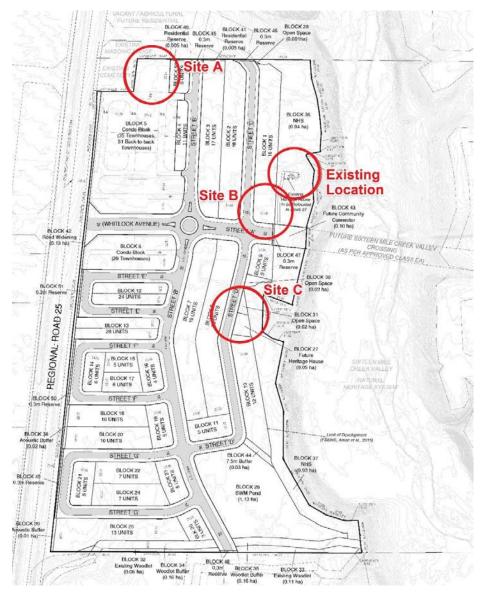
Figure 68: Sites considered for relocation of Bowes House.

Three alternative sites were considered as part of Option 2 (Figure 68), but only Alternative C was considered appropriate (Table 4).

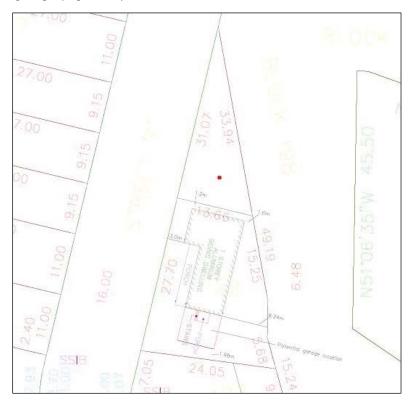
Figure 69: Siting of Bowes House on Block 27 showing orientation, setbacks, surrounding lots and potential location for a garage.

To demonstrate how Bowes House will appear on Block 27, Mattamy has prepared a preliminary site plan that includes provision for a garage (Figure 69).
