# The Corporation of the Town of Milton

Report To:	Council
From:	M. Paul Cripps, P. Eng., Commissioner, Engineering Services
Date:	October 28, 2019
Report No:	ENG-029-19
Subject:	Transport Canada Rail Regulations - Update on Financial Requirements
Recommendation:	<b>THAT ENG-029-19 be received for information related to the 2020 Capital Budget.</b>

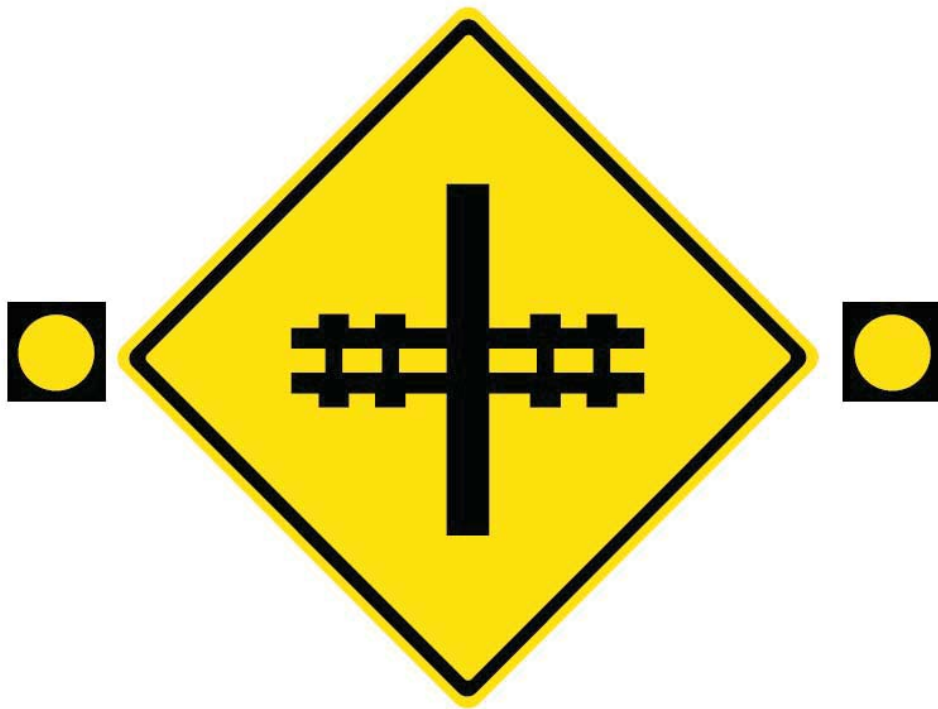
Appendix I

**PREPARE TO STOP AT RAILWAY CROSSING  
AHEAD Sign (With Amber Flashers)**

On the east approach, the light units are not continuously visible (obstructed by horizontal curve, tree branches) throughout the SSD to vehicles approaching the crossing. A Prepare to Stop at Railway Crossing sign and AAWS is required for this grade crossing. (See Appendix I). Staff continue to work with Guelph Junction Railway and Milton Hydro regarding the installation of power cables for the AAWS. There may be an option of using overhead cables versus underground conduit in order to reduce the cost of the installation of the system. As this work is underway, an exact cost is not yet available.
